ANALYSIS OF BROWNFIELDS CLEANUP ALTERNATIVES

**Warden Plaza
908 1st Avenue South
Fort Dodge, Iowa 50501**

**City of Fort Dodge
819 1st Avenue S.
Fort Dodge, Iowa 50501**

October 18, 2023

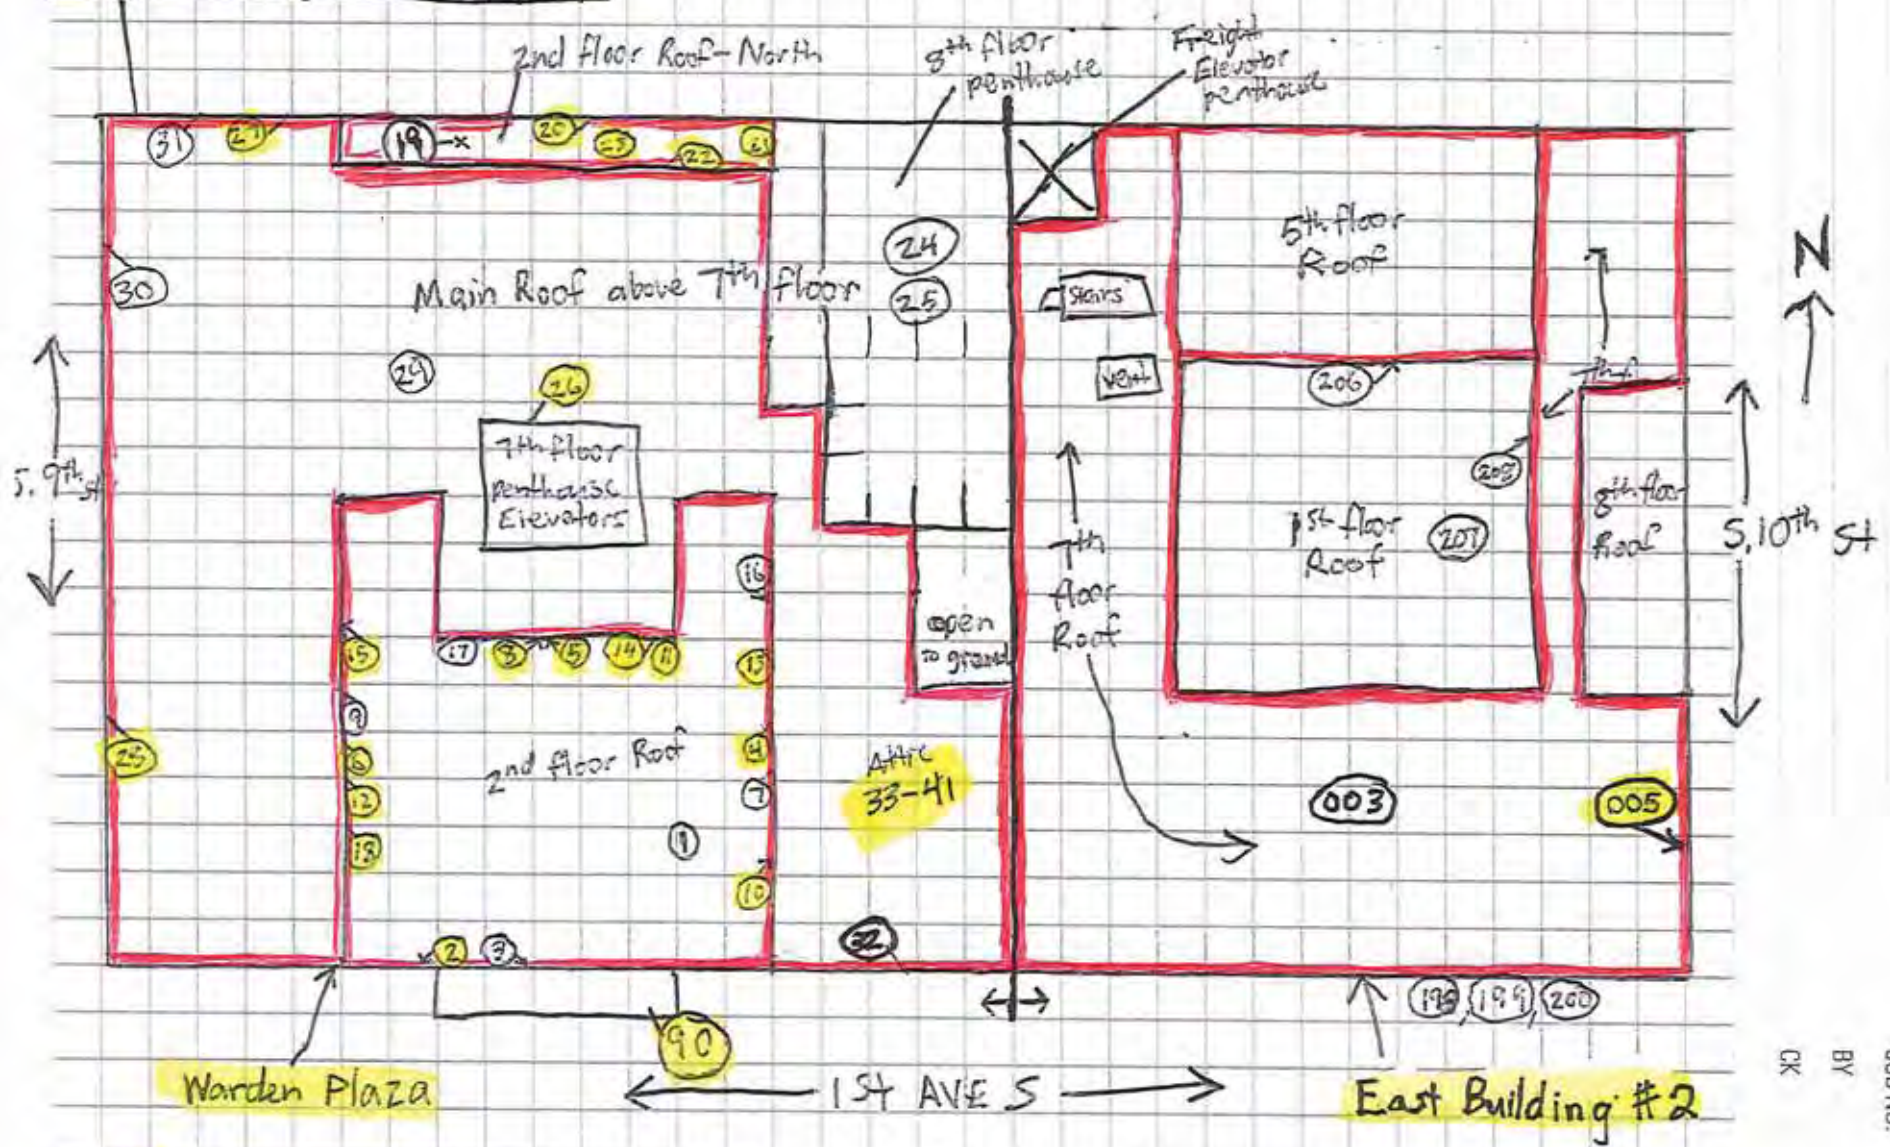
Roof of Both Buildings

All windows have asbestos glazing

= Asbestos Containing

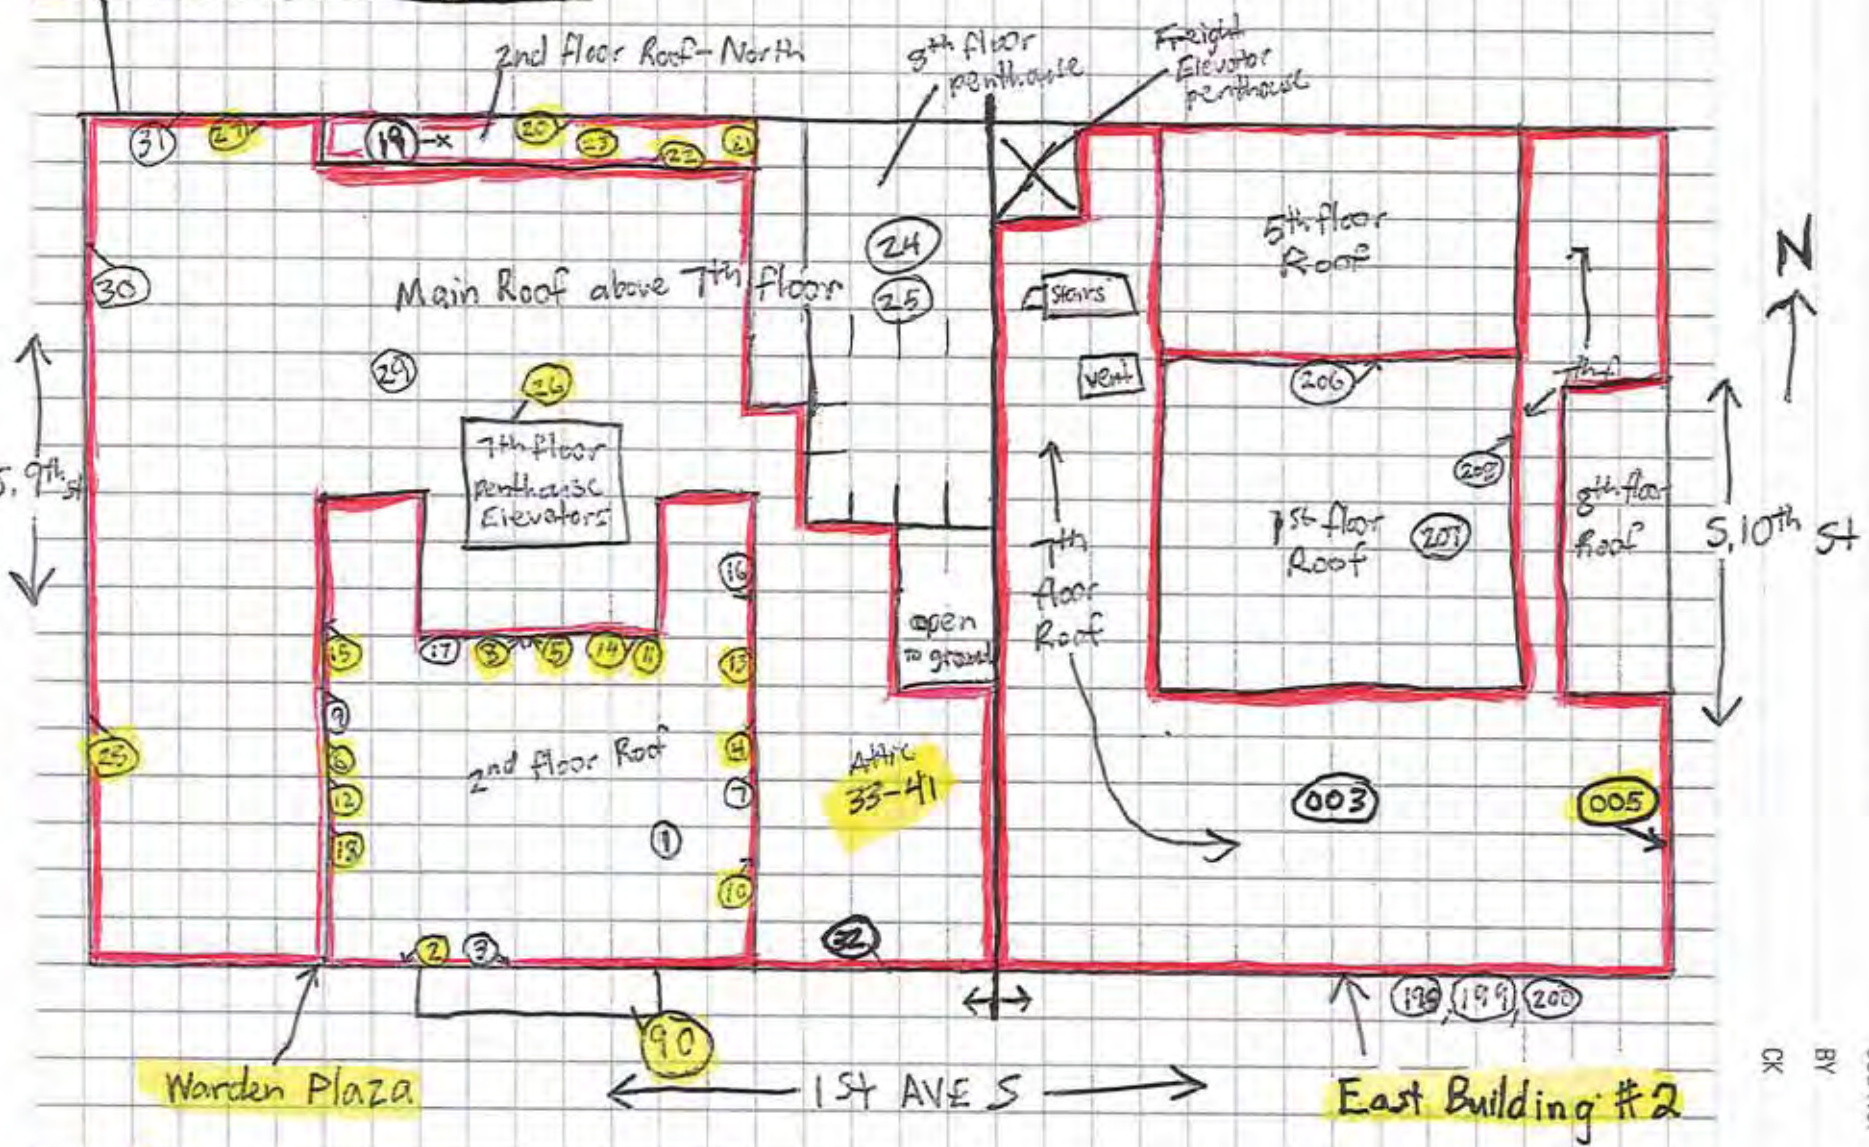
Roof of Both Buildings

All windows have asbestos glazing

= Asbestos Containing
 - = Asbestos Parapet wall Flashing Roof & Attic sample locations

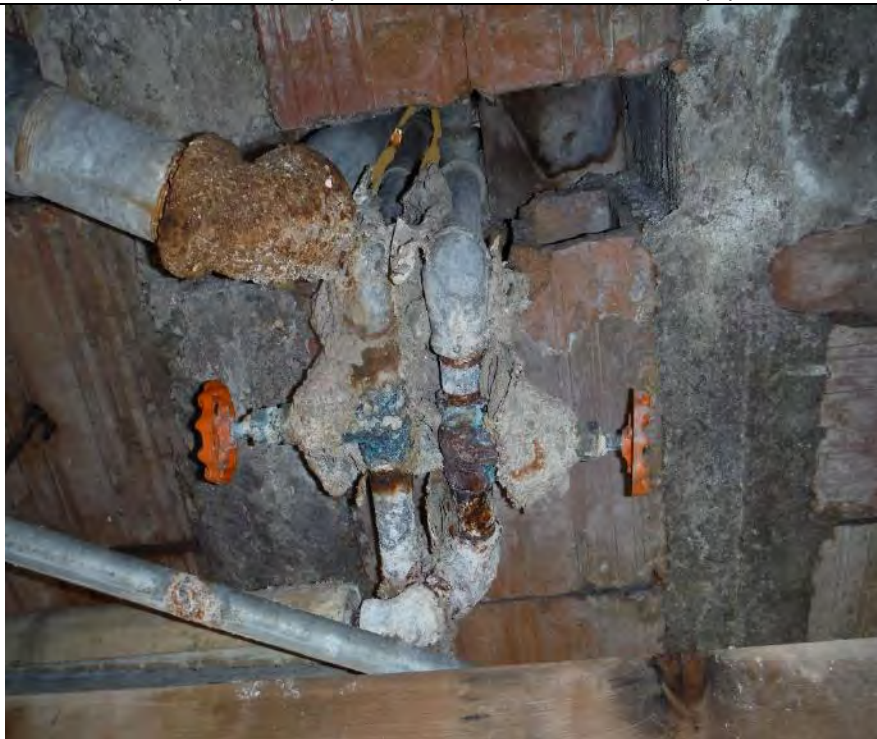
Samples 33-35 Pipe Insulation – Millboard on 1" pipes

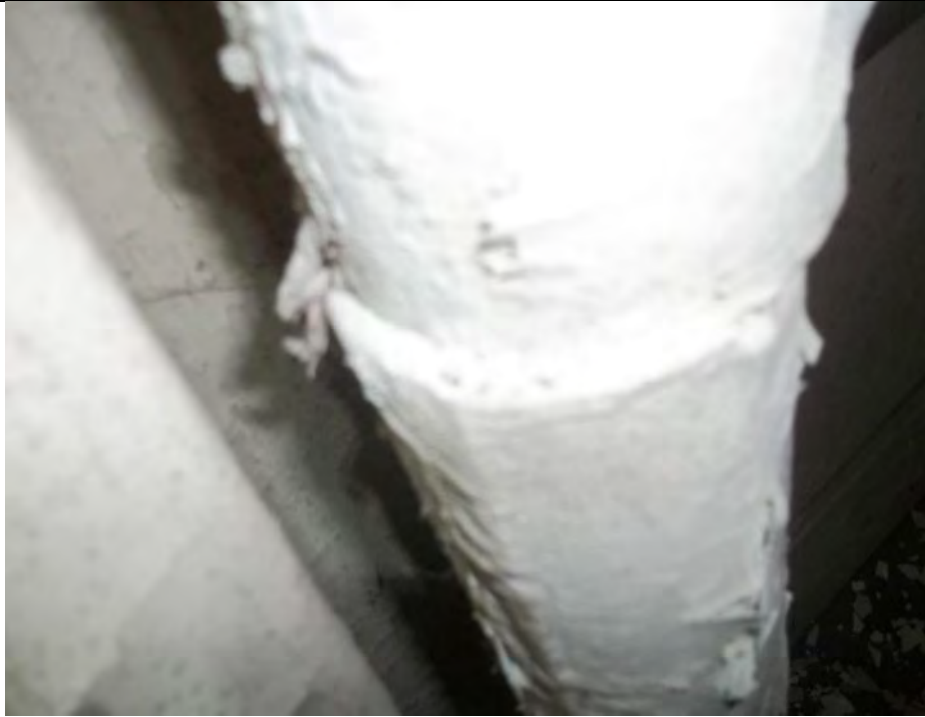
Samples 36 – 38 Mudded Fittings. Example of poor condition of fitting

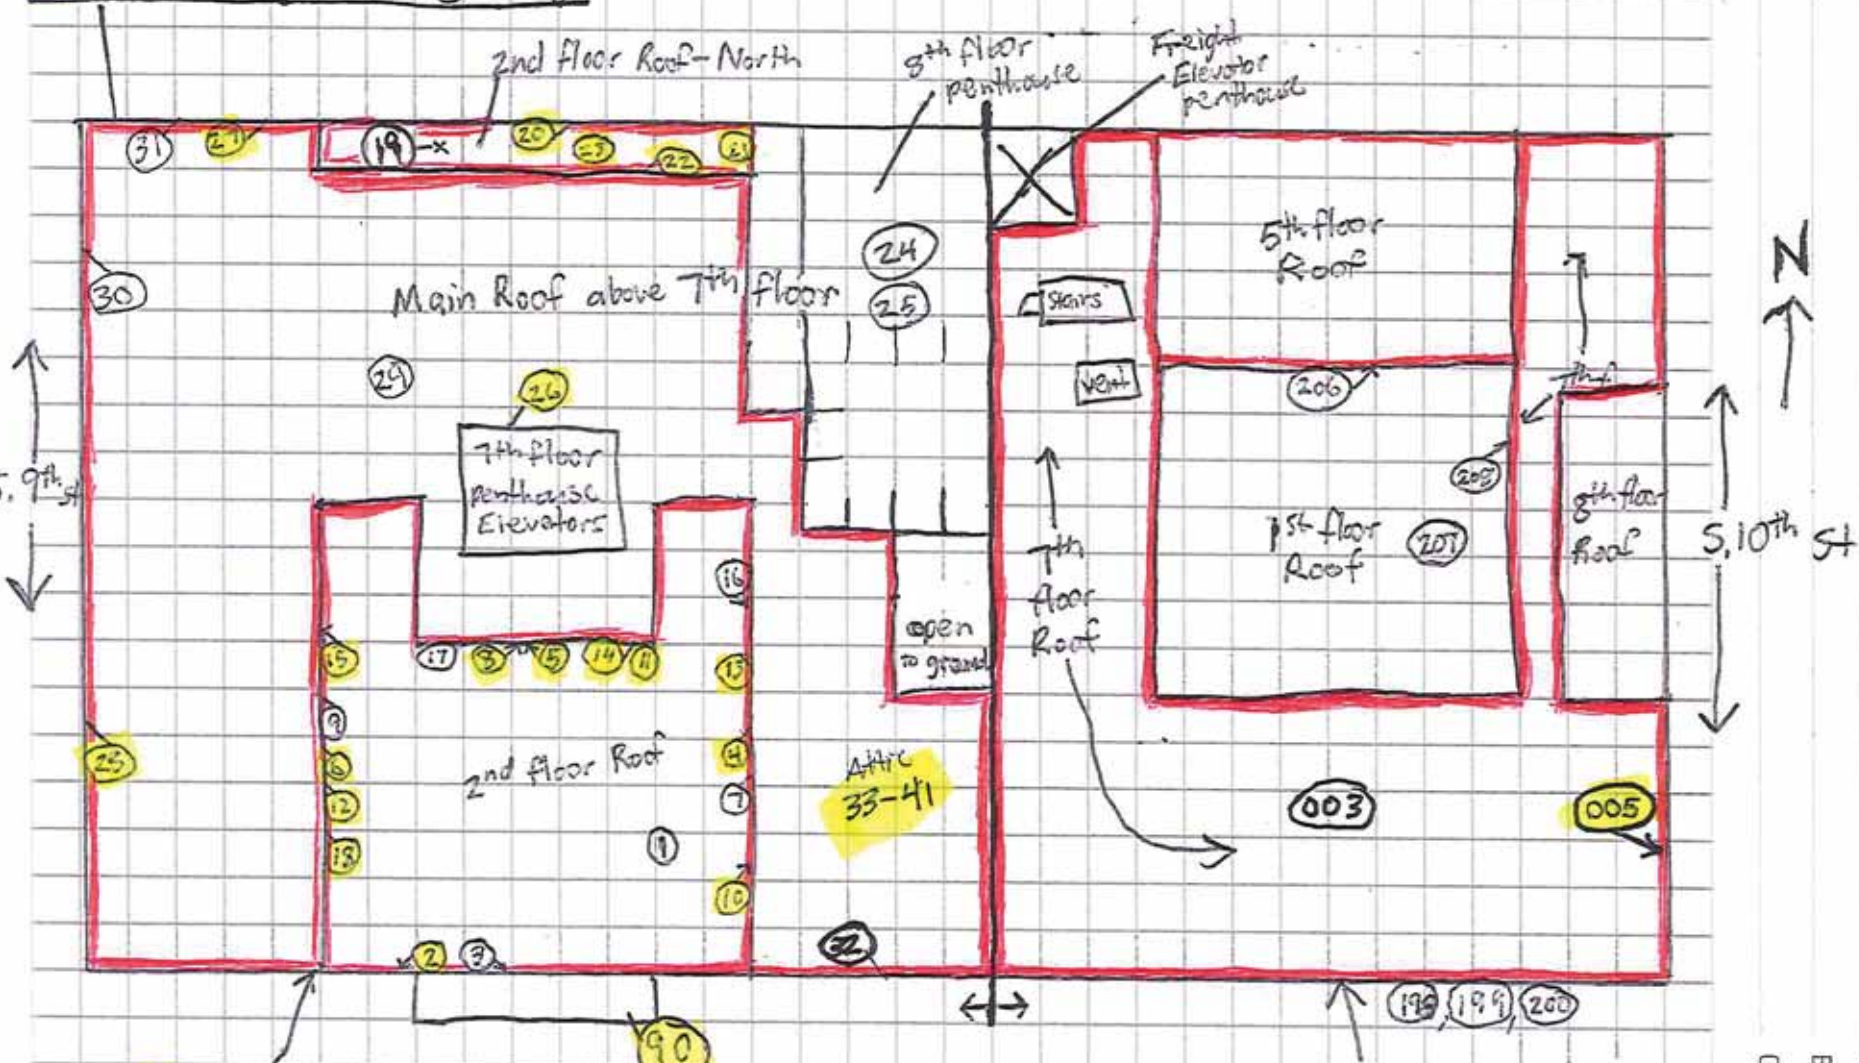
Roof of Both Buildings

All windows have asbestos glazing

= Asbestos Containing
 - = Asbestos Parapet wall Flashing Roof & Attic sample locations

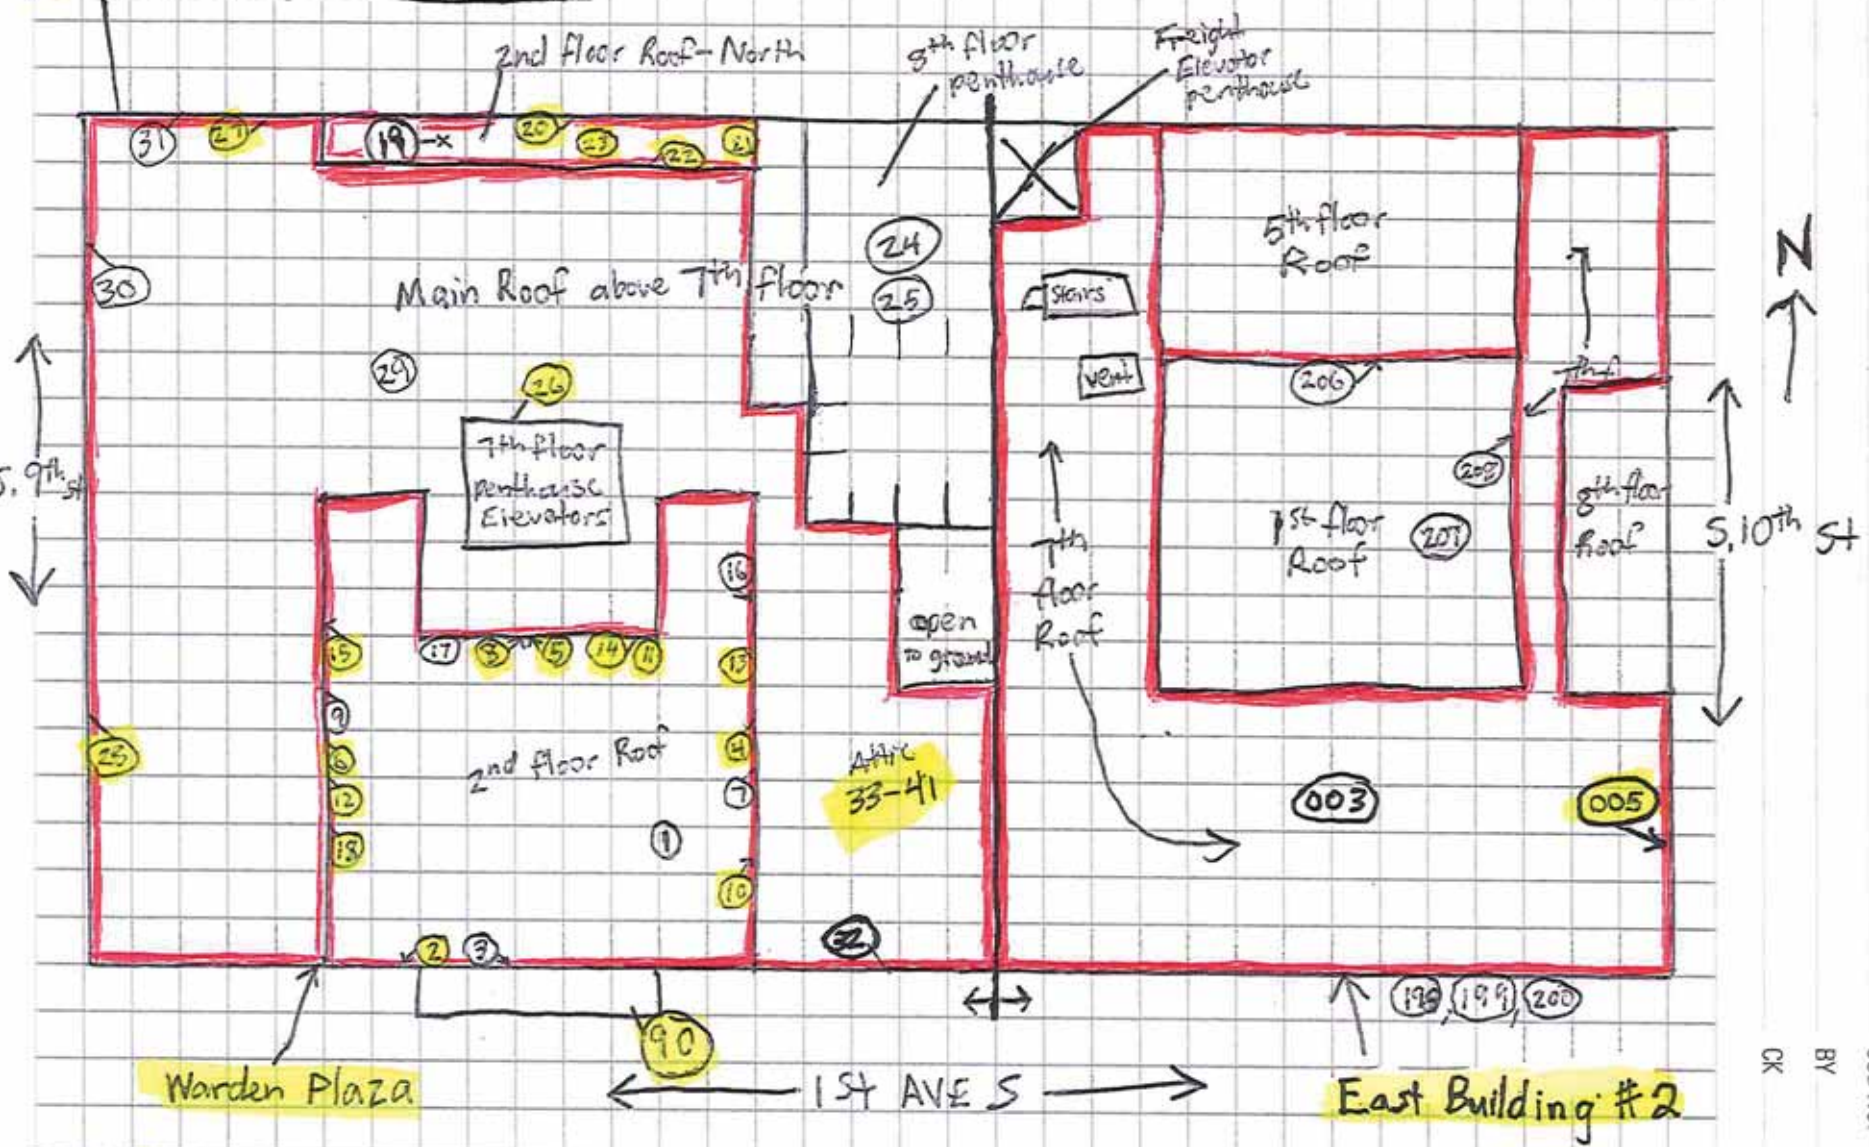
Roof of Both Buildings

All windows have asbestos glazing

= Asbestos Containing
 — = Asbestos Parapet wall Flashing Roof & Attic sample locations

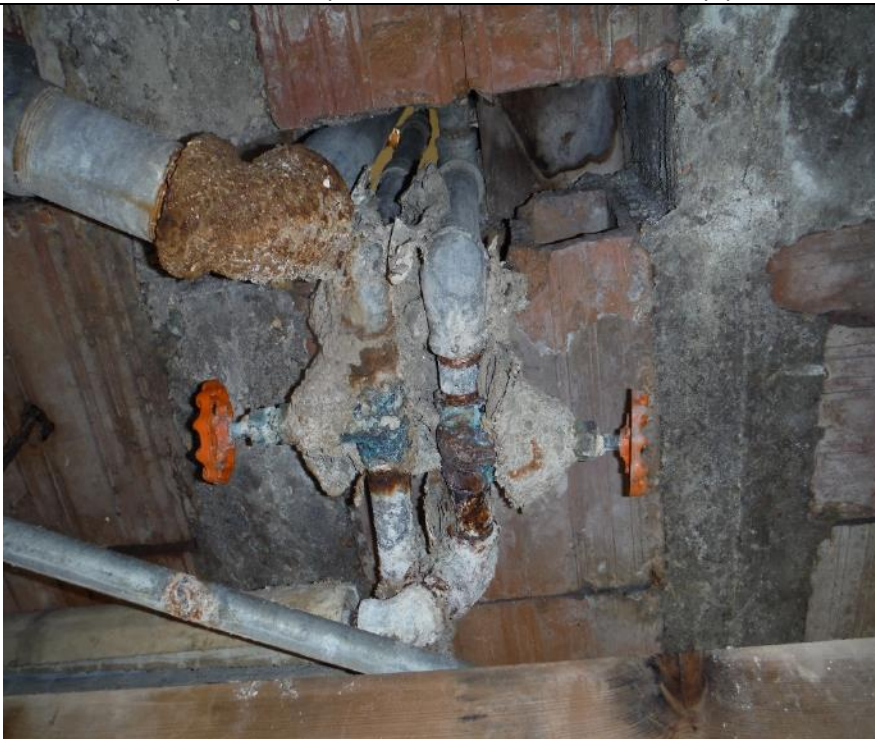
Samples 33-35 Pipe Insulation – Millboard on 1" pipes

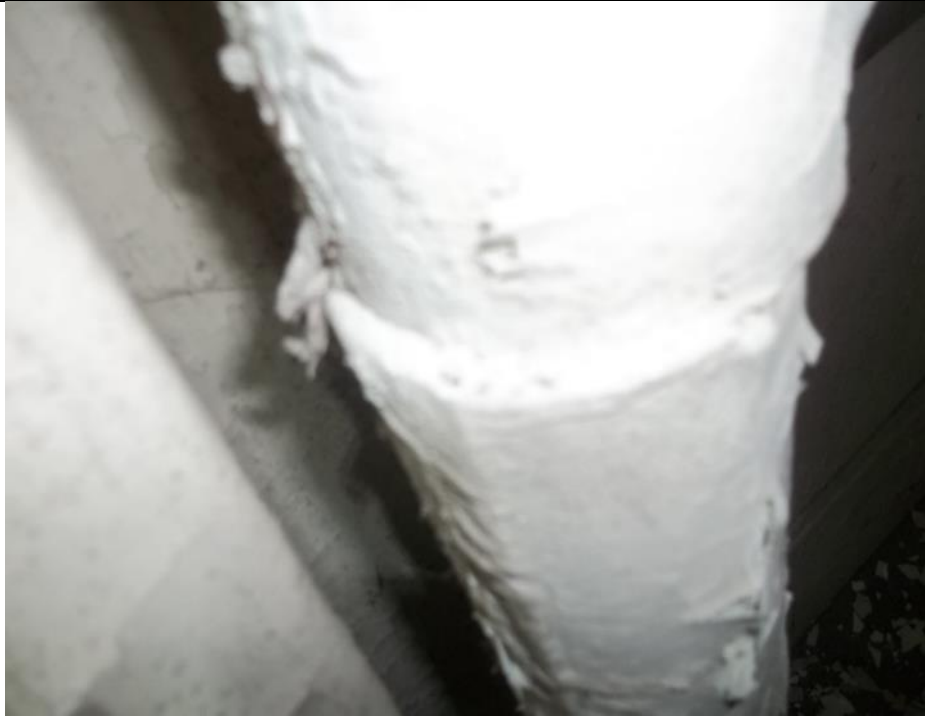
Samples 36 – 38 Muddled Fittings. Example of poor condition of fitting

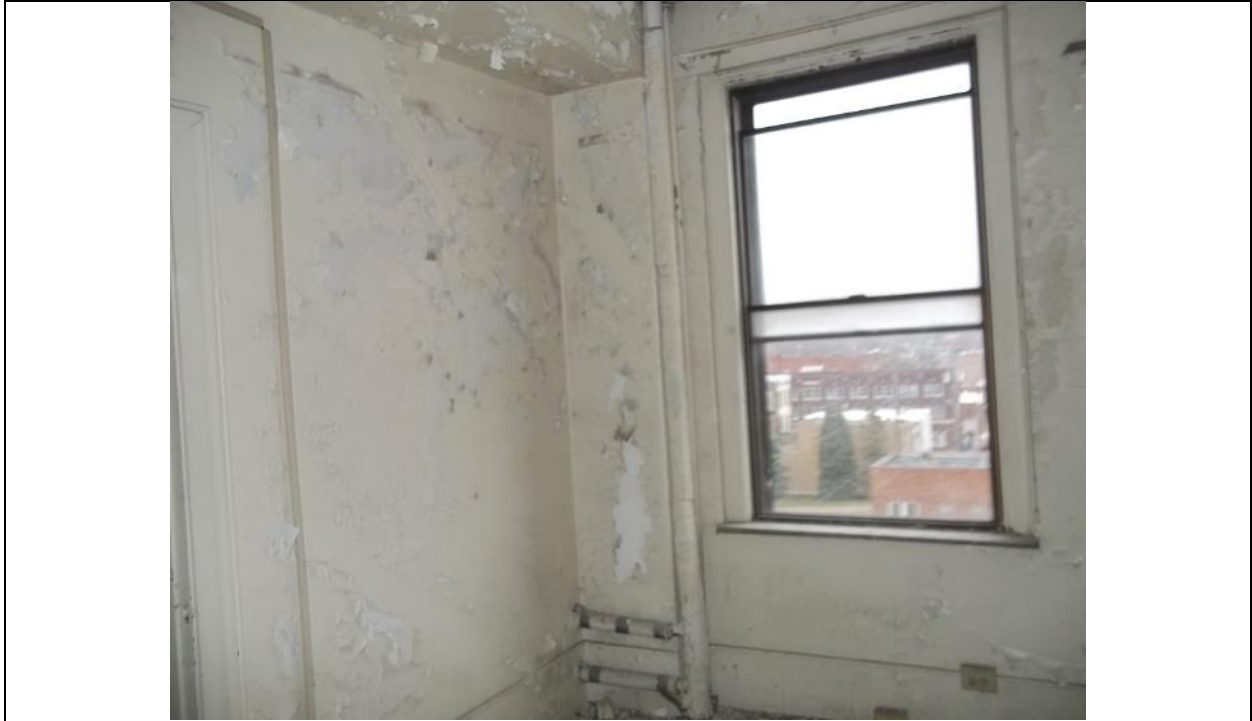
Samples 151-153 Mudded fittings and Asbestos Debris throughout

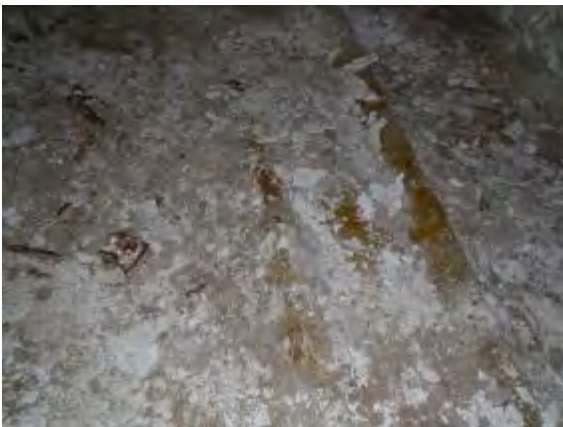
General Condition of Paint and Substrate
