ANALYSIS OF BROWNFIELDS CLEANUP ALTERNATIVES

**Warden Plaza
908 1st Avenue South
Fort Dodge, Iowa 50501**

**City of Fort Dodge
819 1st Avenue S.
Fort Dodge, Iowa 50501**

October 18, 2023

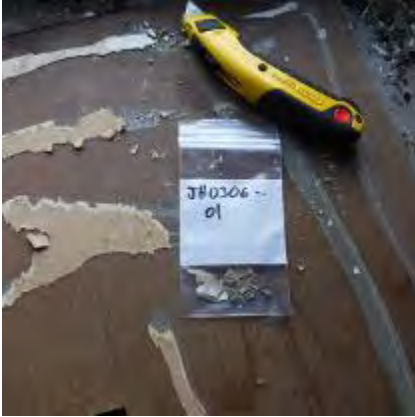
E BLDG 01 – Wall Mastic

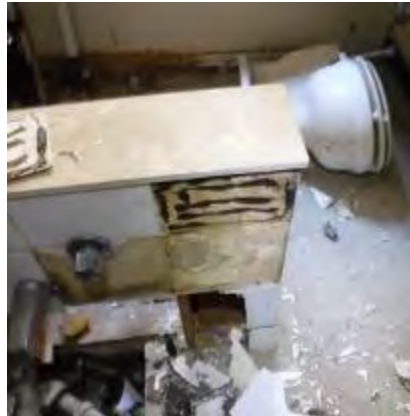
E BLDG 40 – Bathroom Tile Mastic

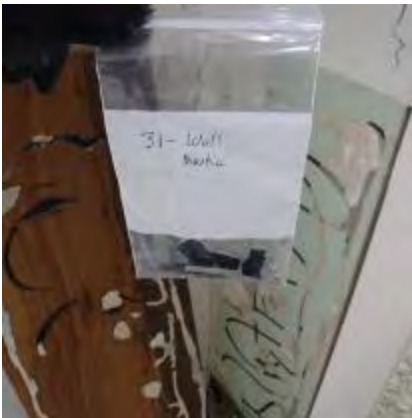
Warden 31 – Wood Wall Mastic

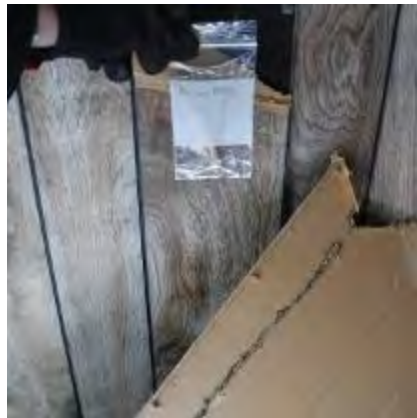
Warden 47 – Wall Mastic

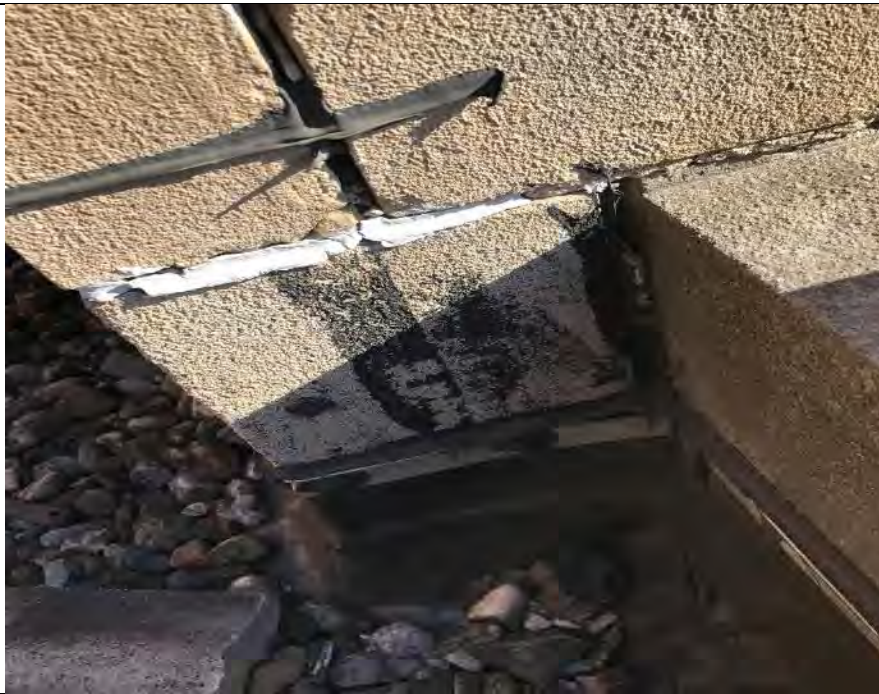
Sample 2 – White Caulking on Concrete Parapet wall – 2nd Story Roof

Note 2: Parapet walls on both buildings contain asbestos under the top layer of roofing on the original parapet flashing (black). There is asbestos caulk (silver) on the parapet wall for the 2nd and 7th floors and has been used as patch/repairs in various roof locations.

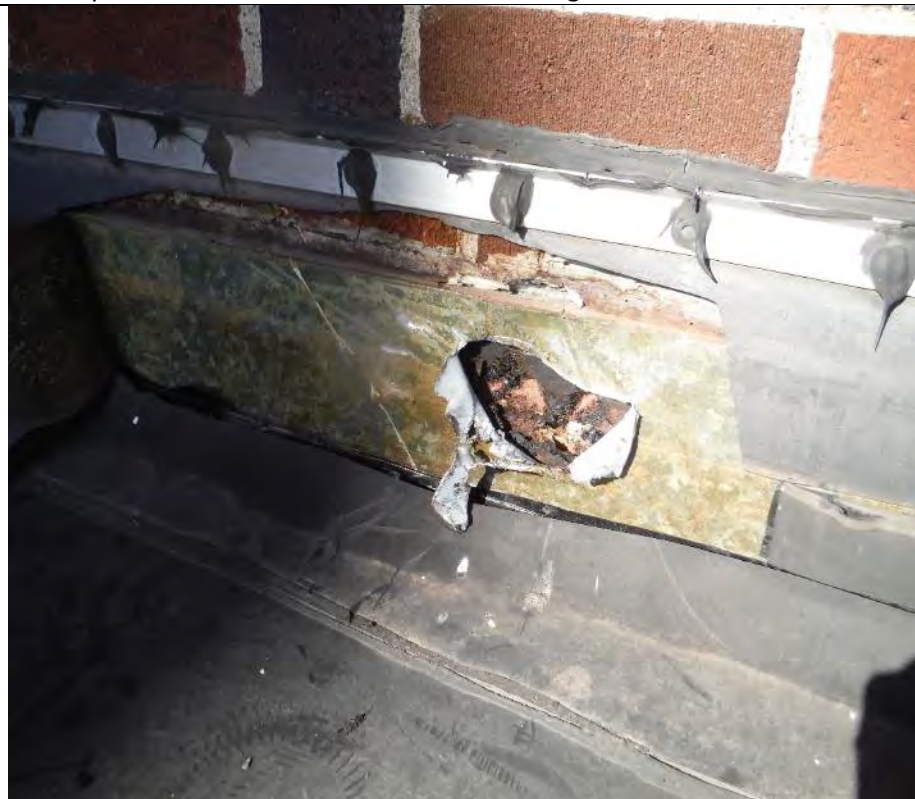
Samples 13-15 Parapet Wall Flashing – Black Tar
Sample 18 - Silver Caulking Above Black Tar

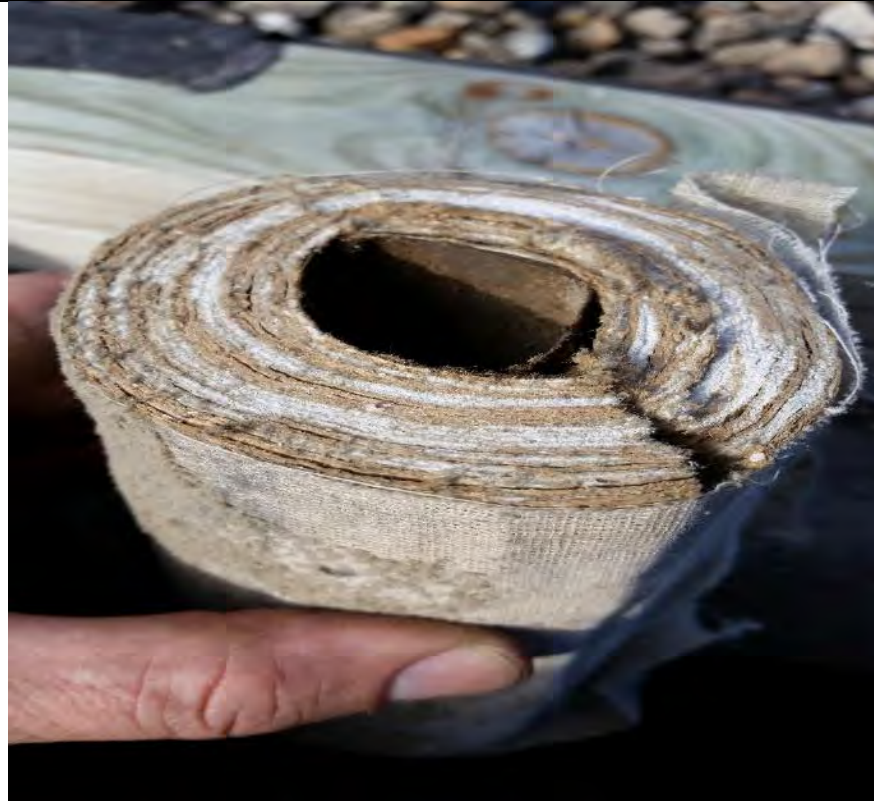
Samples 33-35 Pipe Insulation – Millboard on 1" pipes

Note 3: Insulation for the heating and domestic water supply was confirmed to contain asbestos in both buildings and is located throughout the basement to attic and chases or cavities in between). It appeared some pipes had been abated and partially abated. There were locations where fiberglass insulation was observed to be placed over top the asbestos pipe insulation. Based on the observations, all pipe insulation is to be considered asbestos-containing throughout the building as asbestos may be underneath. In many areas of the building, the exposed asbestos insulation for pipes and the boiler was found to be in poor condition and significantly damaged. The damage includes contamination of the floor and surrounding surfaces. Entry into areas of damaged friable asbestos materials, including pipe or boiler insulation, damaged ceiling texture, and damaged ceiling tiles, should be restricted.

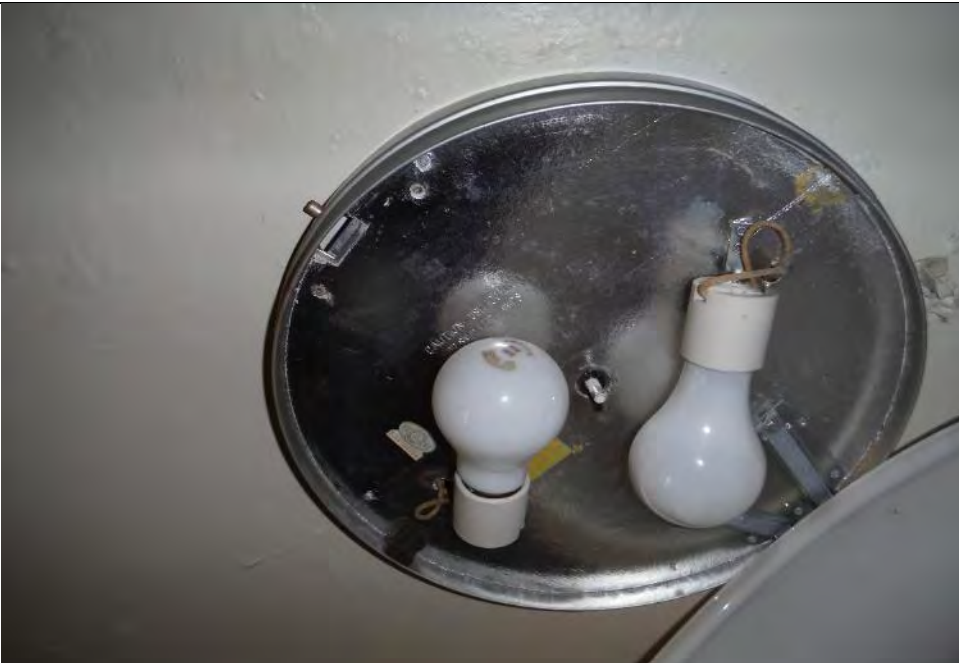
Sample 57 Heat Shield on Circular Lights on the ceilings and Wire Insulation

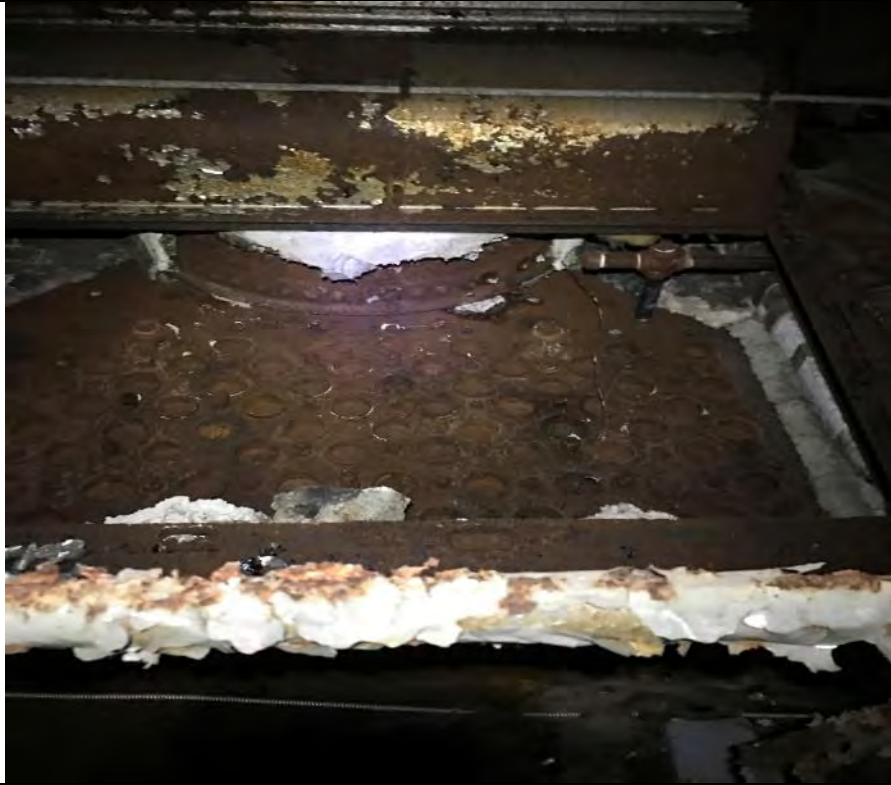
Sample 42 – 44 Boiler Insulation

Note 9: The boiler and piping for both buildings originates in the boiler room which is located in East Building 2 basement. The boiler and pipe insulation in the basement is in poor condition and is significantly damaged in some locations. The boiler contains asbestos gaskets on the floor and on the equipment. Evidence of past abatement work was observed with poly walls remaining and some insulation removed. The basement area of building 2 is contaminated with asbestos insulation on the floors. Overtime, deterioration and foot traffic could expose people and contaminate other areas within the building.

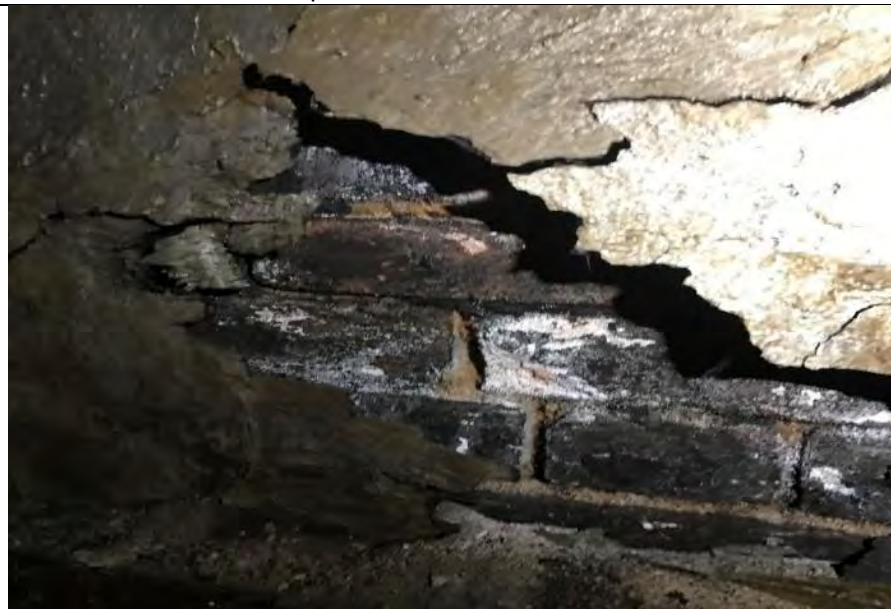
Samples 139-141 – Boiler Wrap – Tar

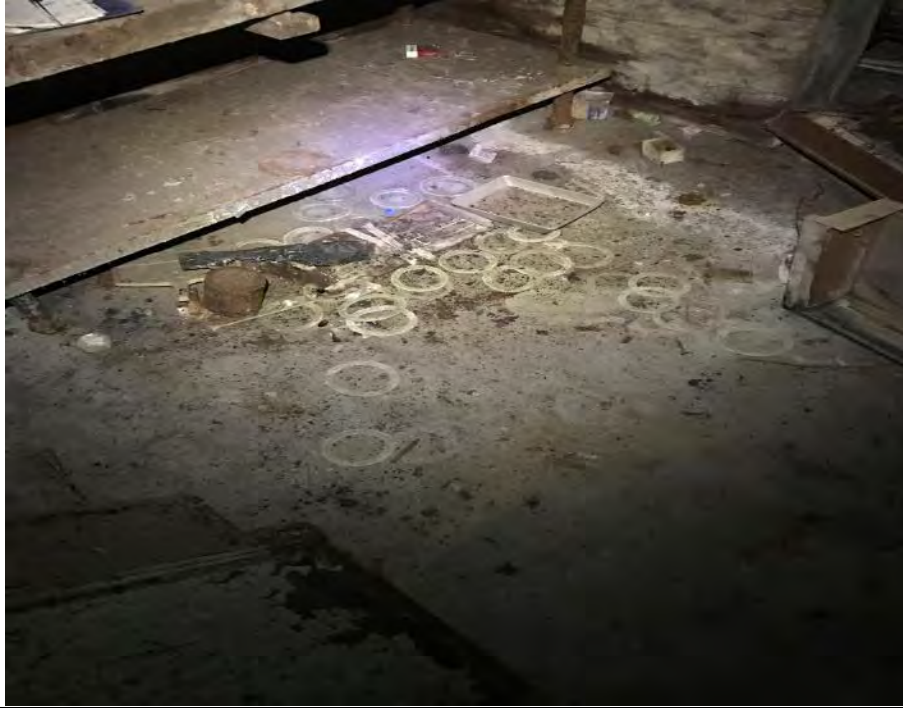
Samples 145-147 Boiler Gaskets covering the floor

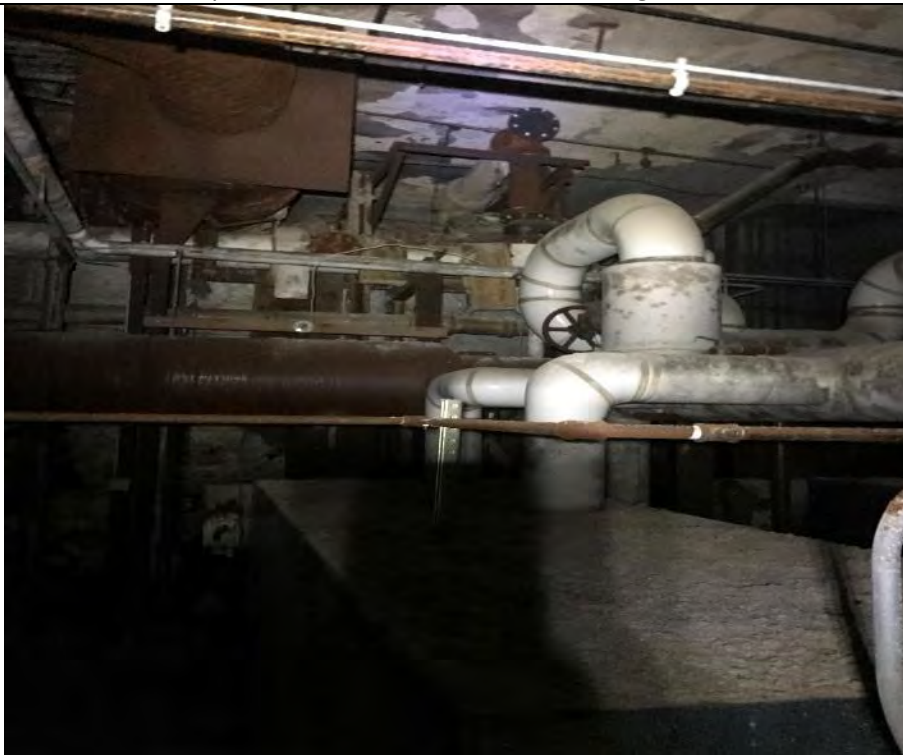
Samples 151-153 Muddied fittings and Asbestos Debris throughout

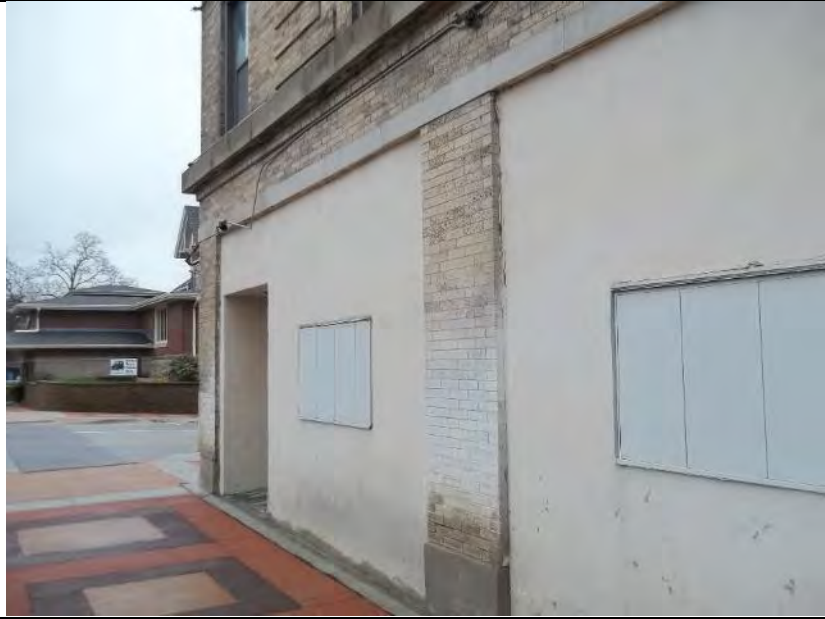
Samples 204 – Caulking around smooth stucco siding

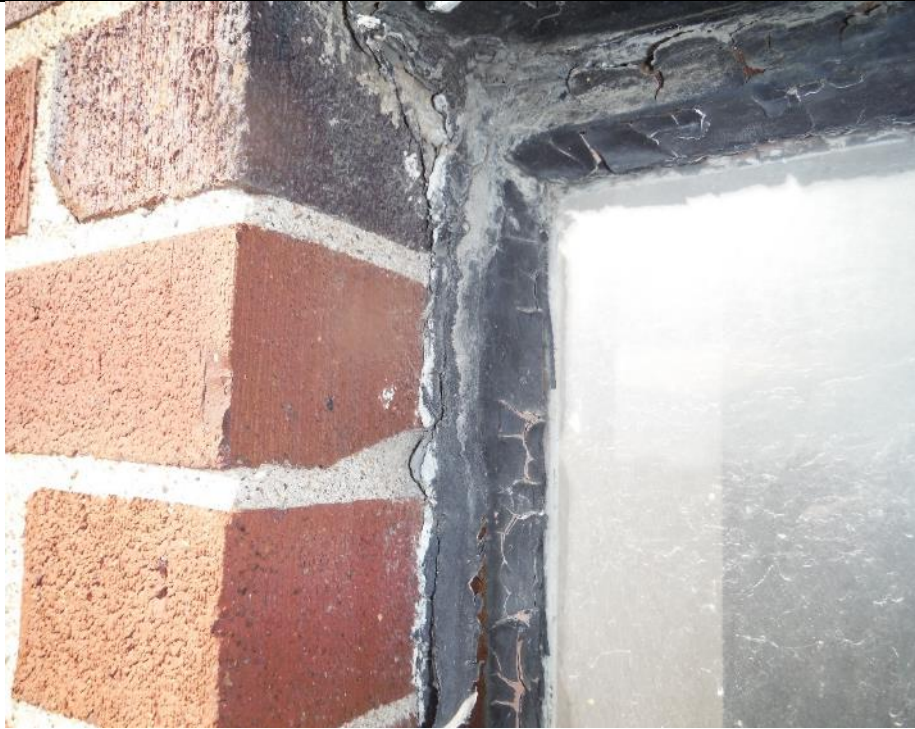
Samples 10-12 Window Frame Black Caulking between Brick and Frame

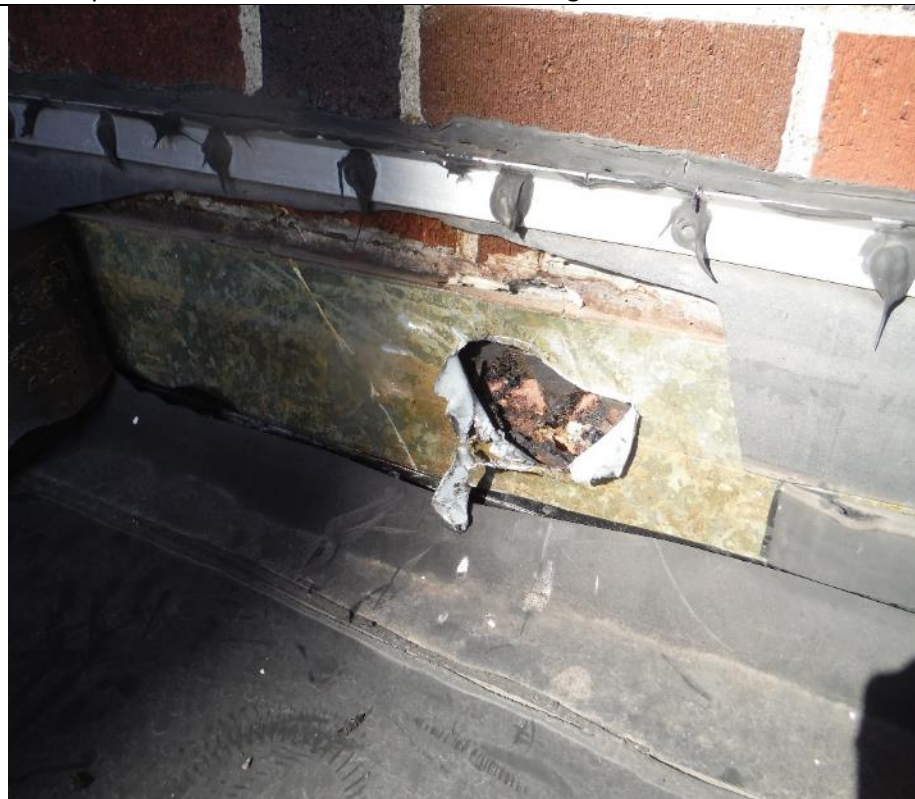
Samples 13-15 Parapet Wall Flashing – Black Tar
Sample 18 - Silver Caulking Above Black Tar

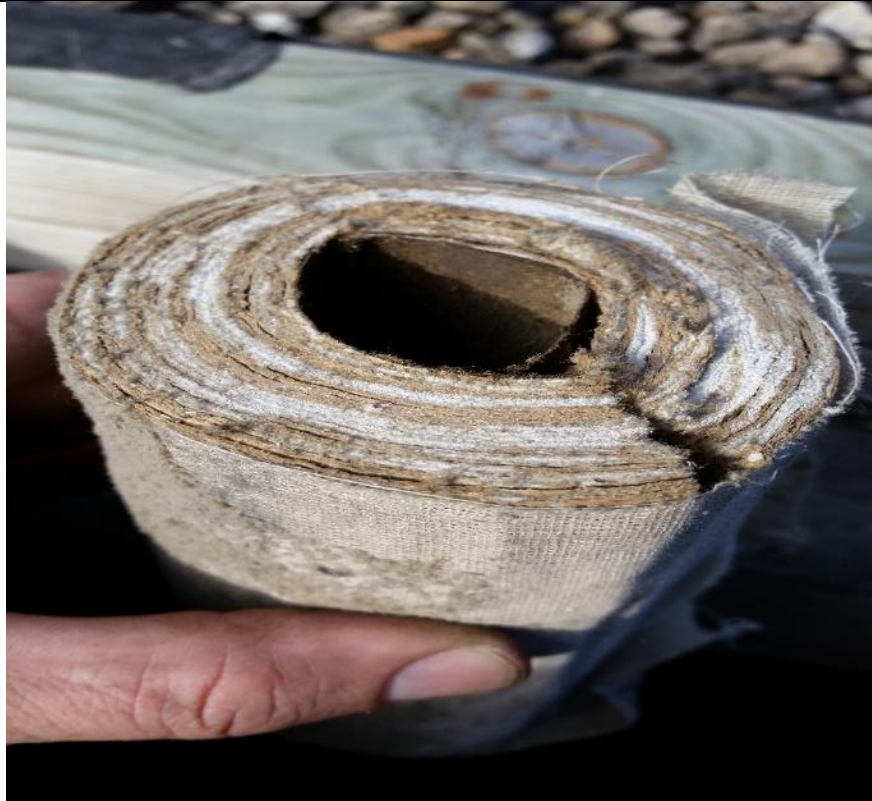
Samples 33-35 Pipe Insulation – Millboard on 1" pipes

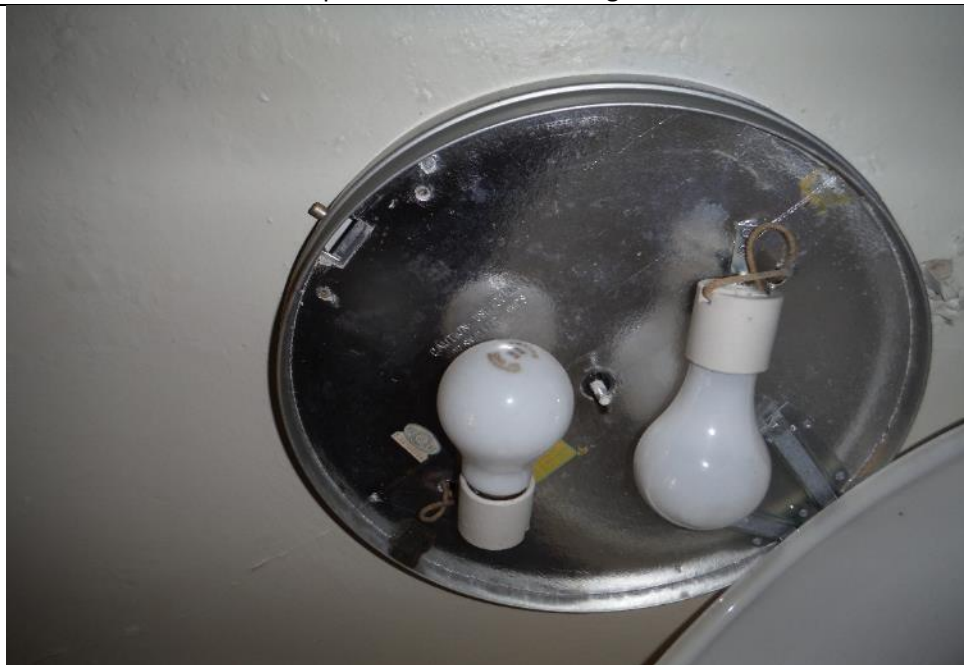
Sample 57 Heat Shield on Circular Lights on the ceilings and Wire Insulation

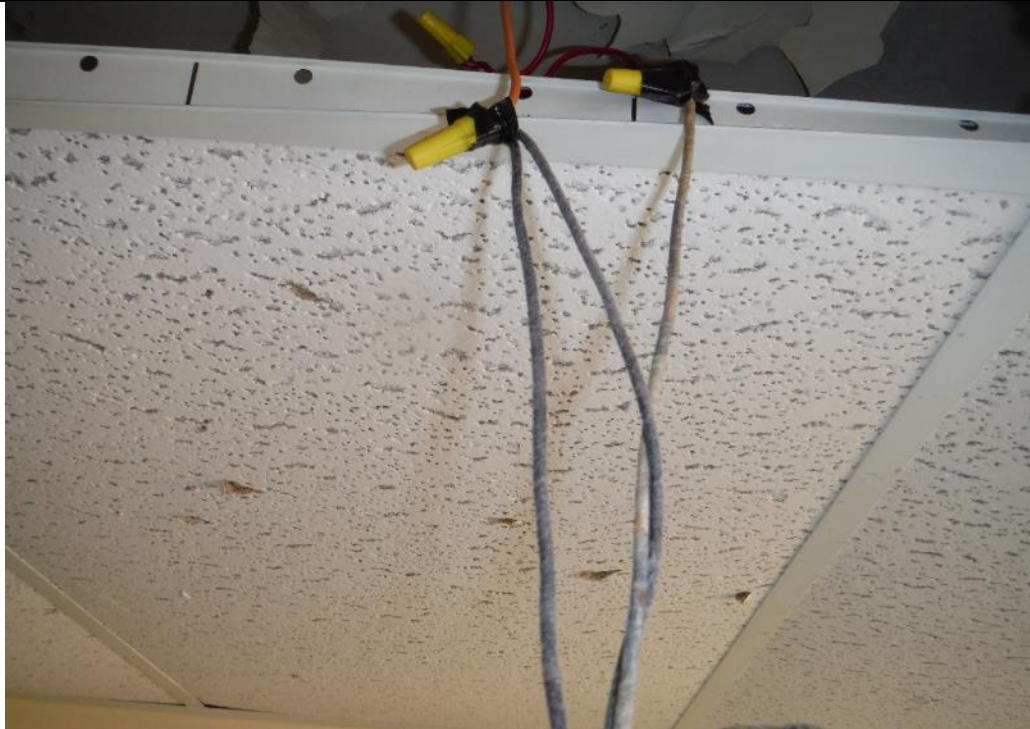
Samples 58 – 59 Electrical Wire Insulation on wires coming from Ceiling Lights

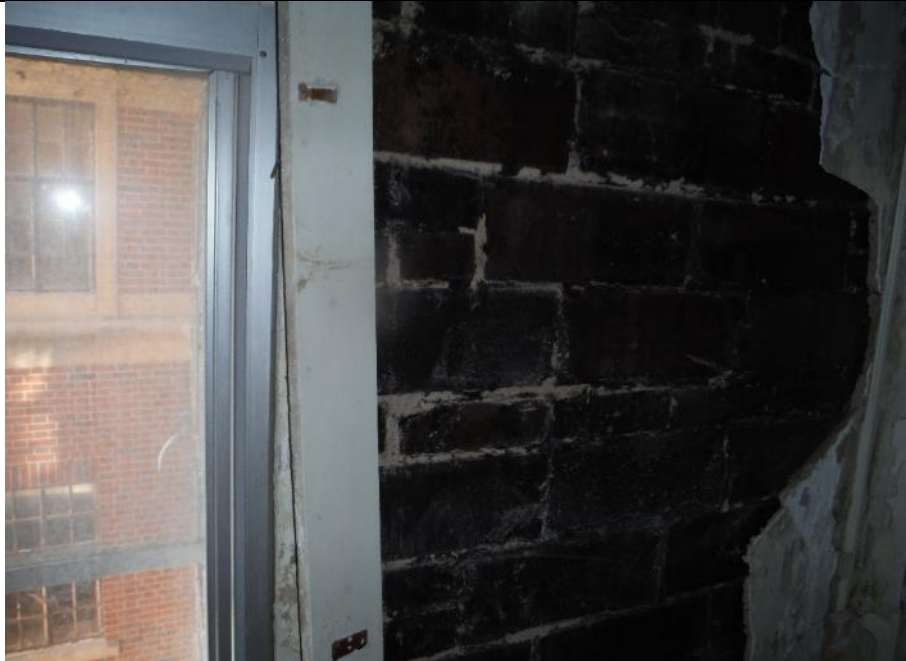
Sample 105 – Black Waterproofing on the inside of the exterior walls

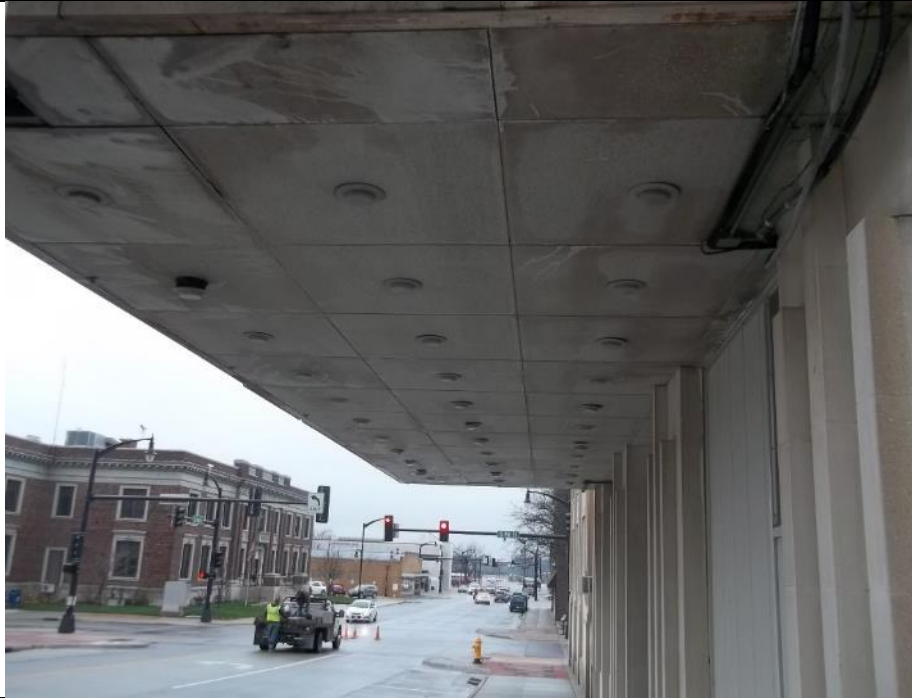
Sample 90 - Transite Soffit over entrance on 1st Ave S.

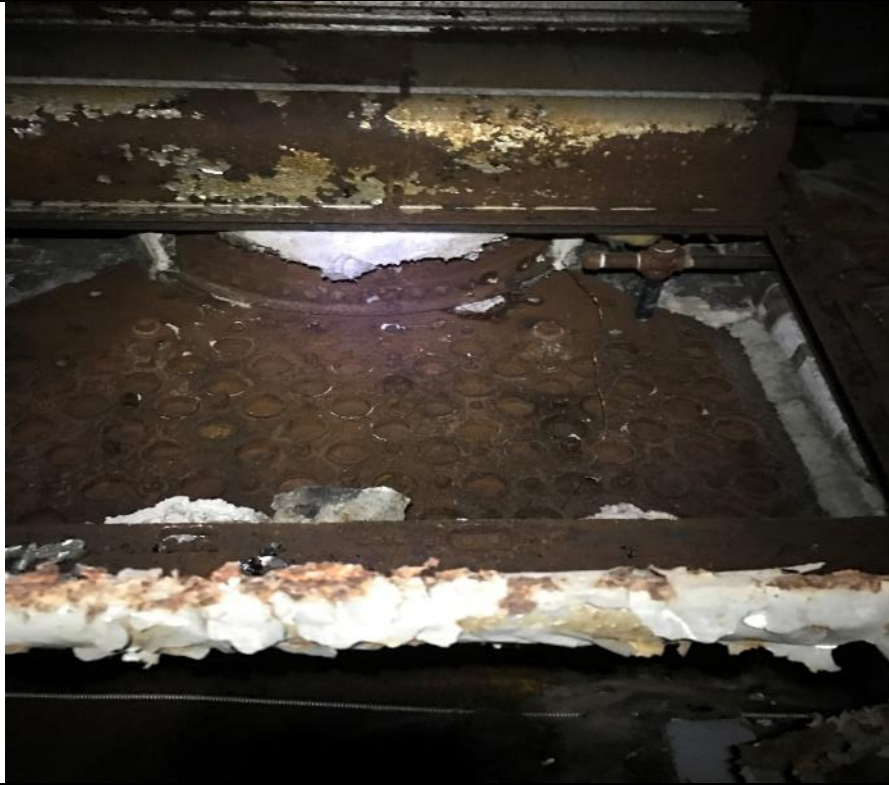
Sample 42 – 44 Boiler Insulation

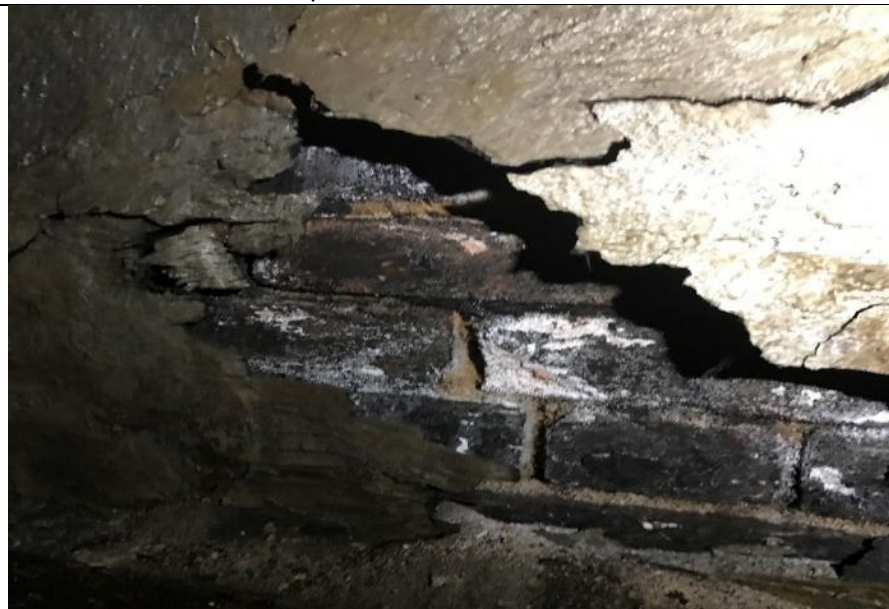
Samples 139-141 – Boiler Wrap – Tar

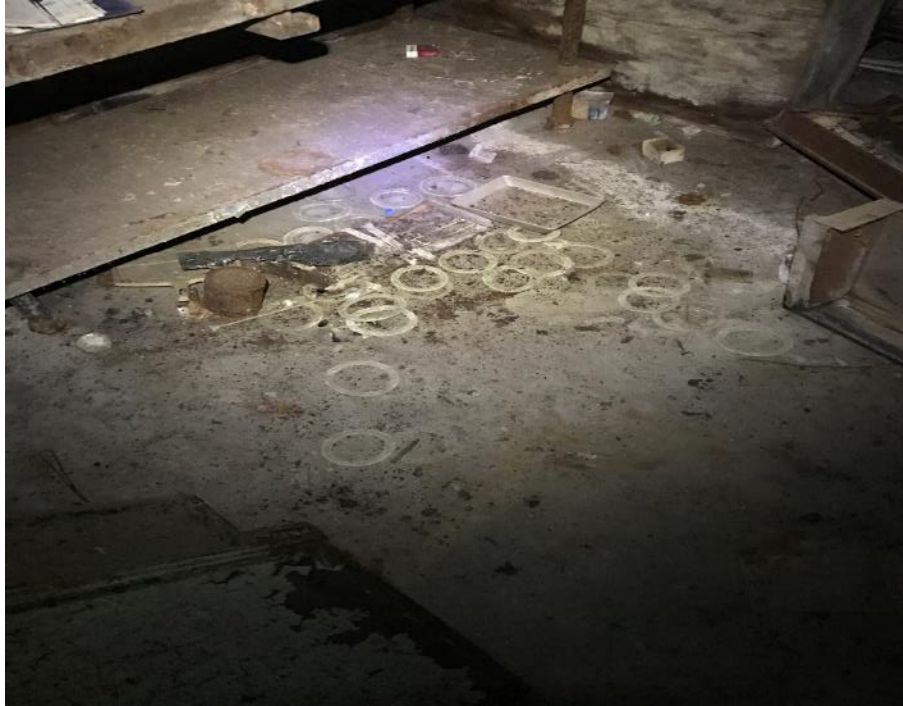
Samples 145-147 Boiler Gaskets covering the floor

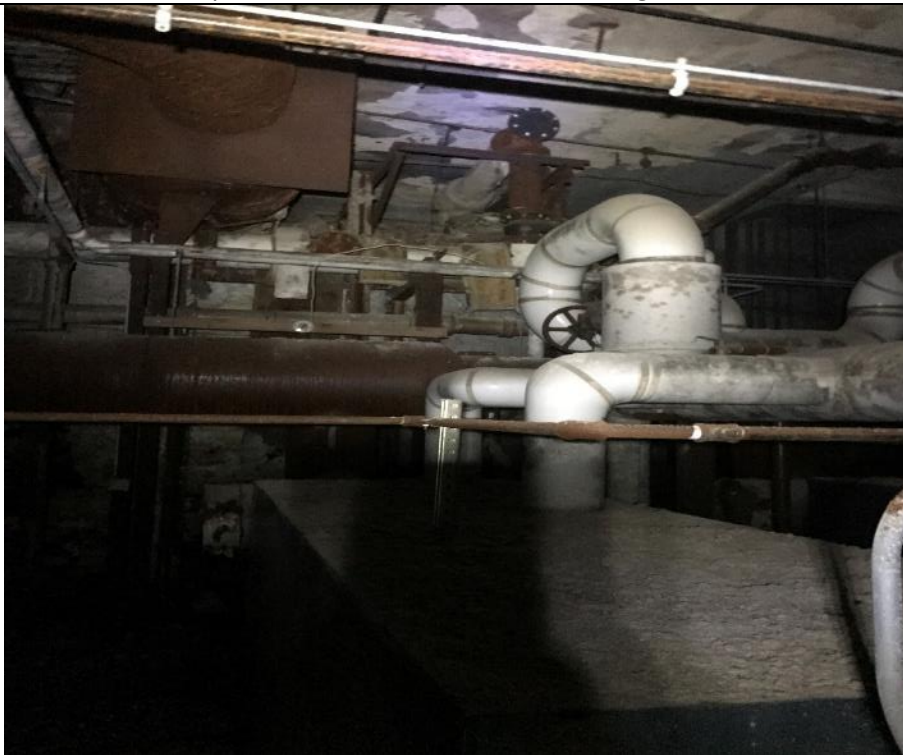
Samples 151-153 Mudded fittings and Asbestos Debris throughout

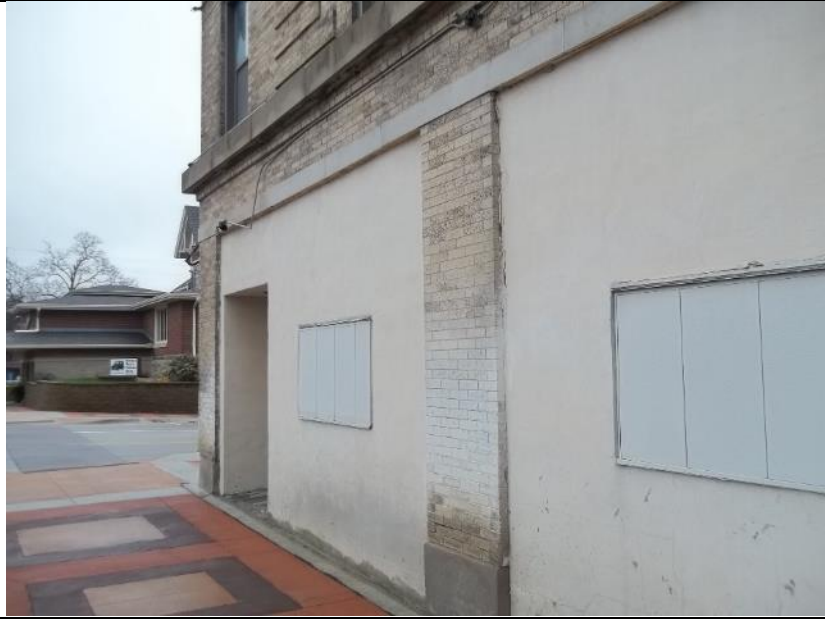
Samples 204 – Caulking around smooth stucco siding

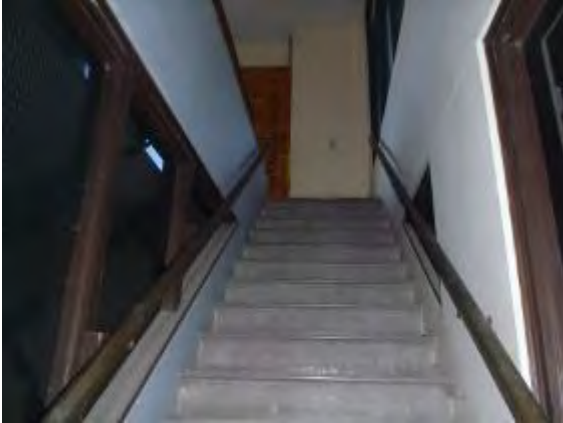
To Basement Stairwell

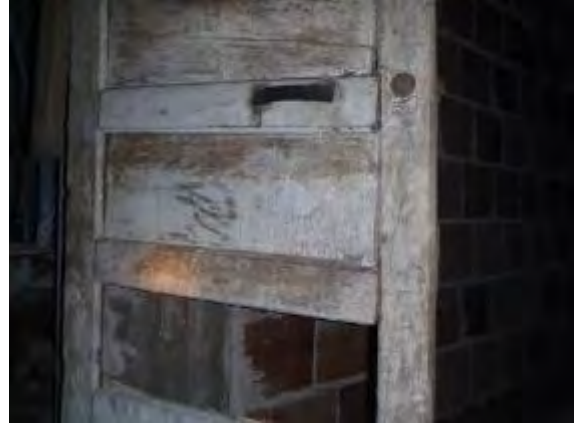
Basement-To Tunnel Door Components

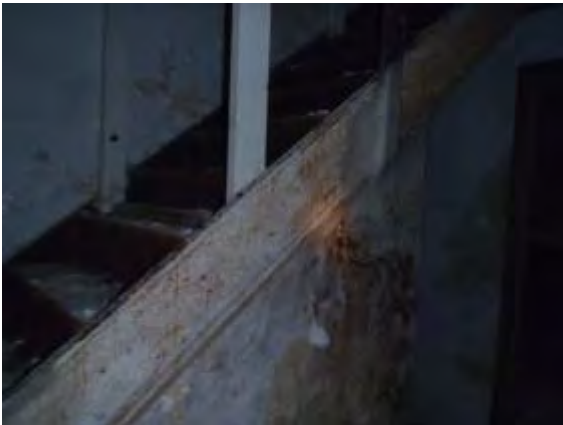
Basement-SE Stair Components

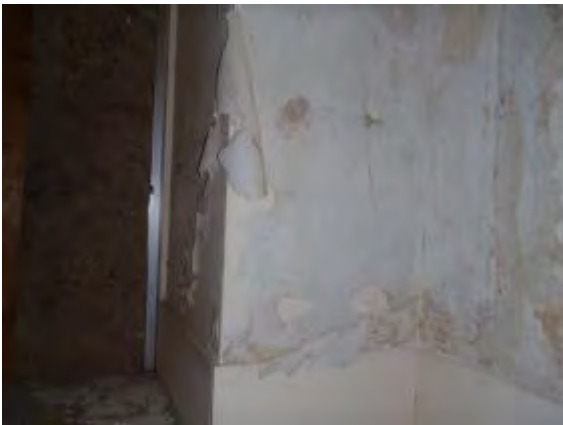
Plaster Walls Throughout

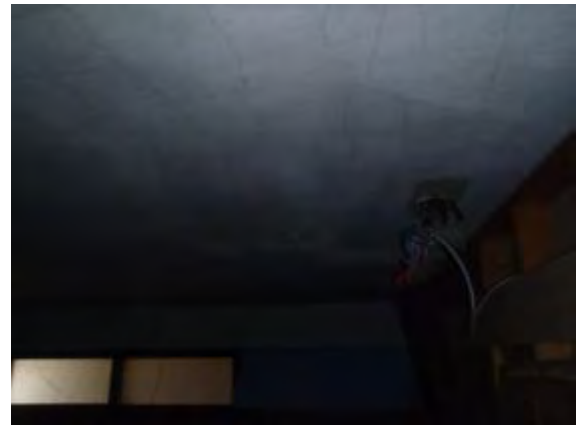
Plaster Ceilings Throughout

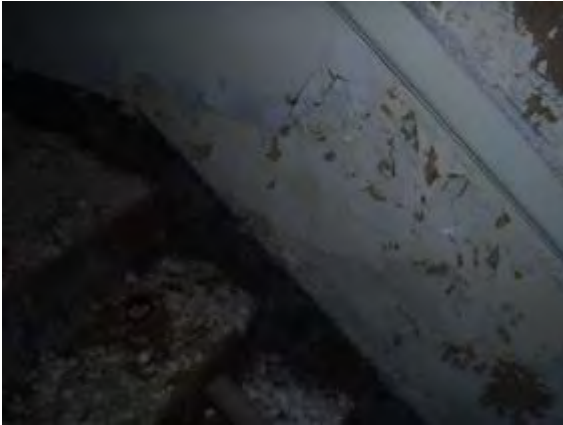
Stairwell Showing Paint Chips on Floor

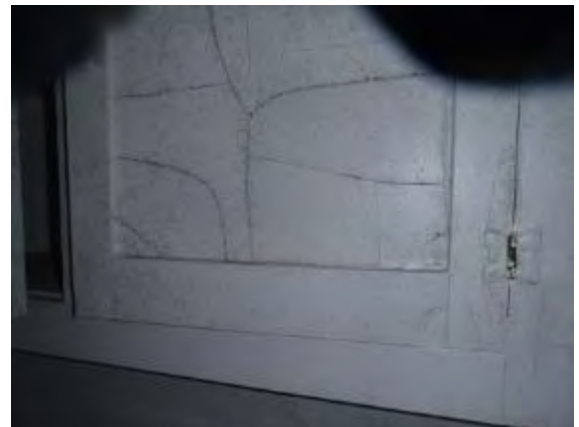
Cabinet and Cabinet Doors

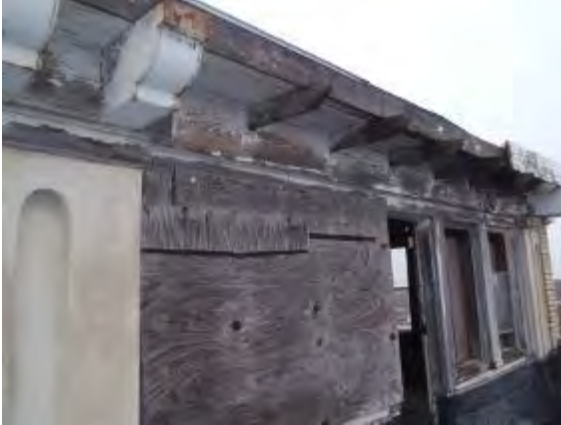
Eave/Soffit and Fascia on Roof

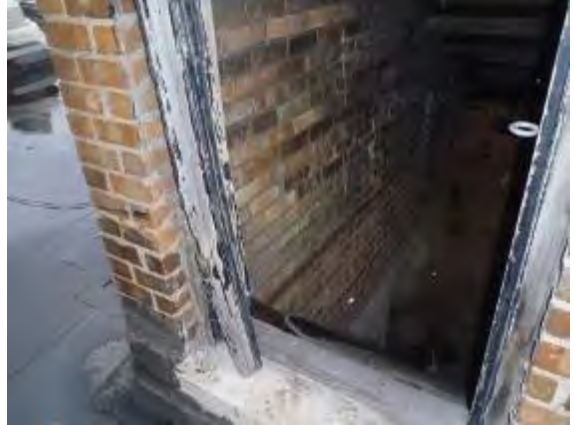
Door Components on Roof

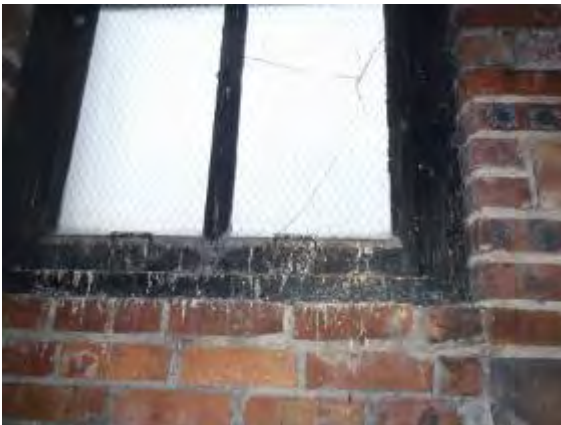
Window Components on Roof

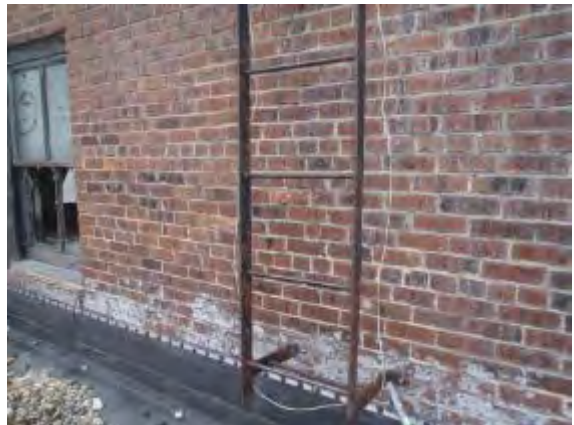
Ladder on Roof

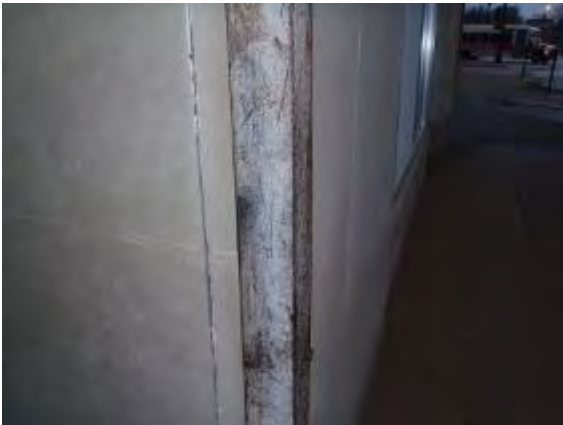
Corner Guard NW Corner

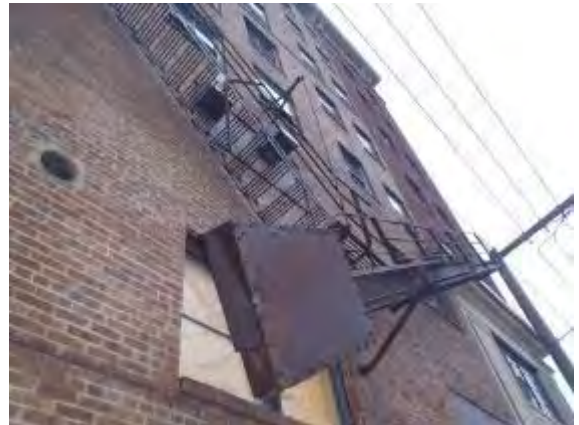
Fire Escape North Side
