ANALYSIS OF BROWNFIELDS CLEANUP ALTERNATIVES

**Warden Plaza
908 1st Avenue South
Fort Dodge, Iowa 50501**

**City of Fort Dodge
819 1st Avenue S.
Fort Dodge, Iowa 50501**

October 18, 2023

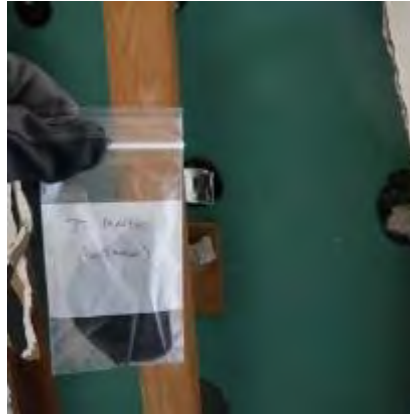
E BLDG 37 – Wall Mastic Puck

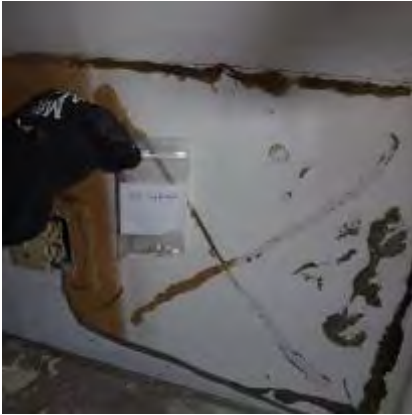
Warden 04 – Backsplash Wall Mastic

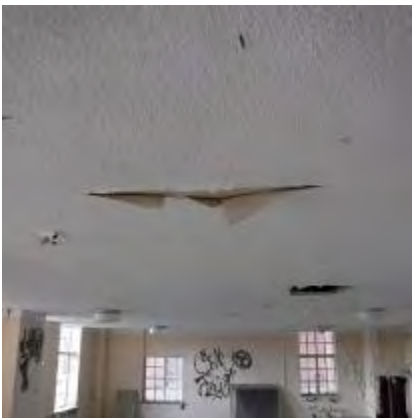
Warden 67a,b,c – Popcorn Ceiling Texture

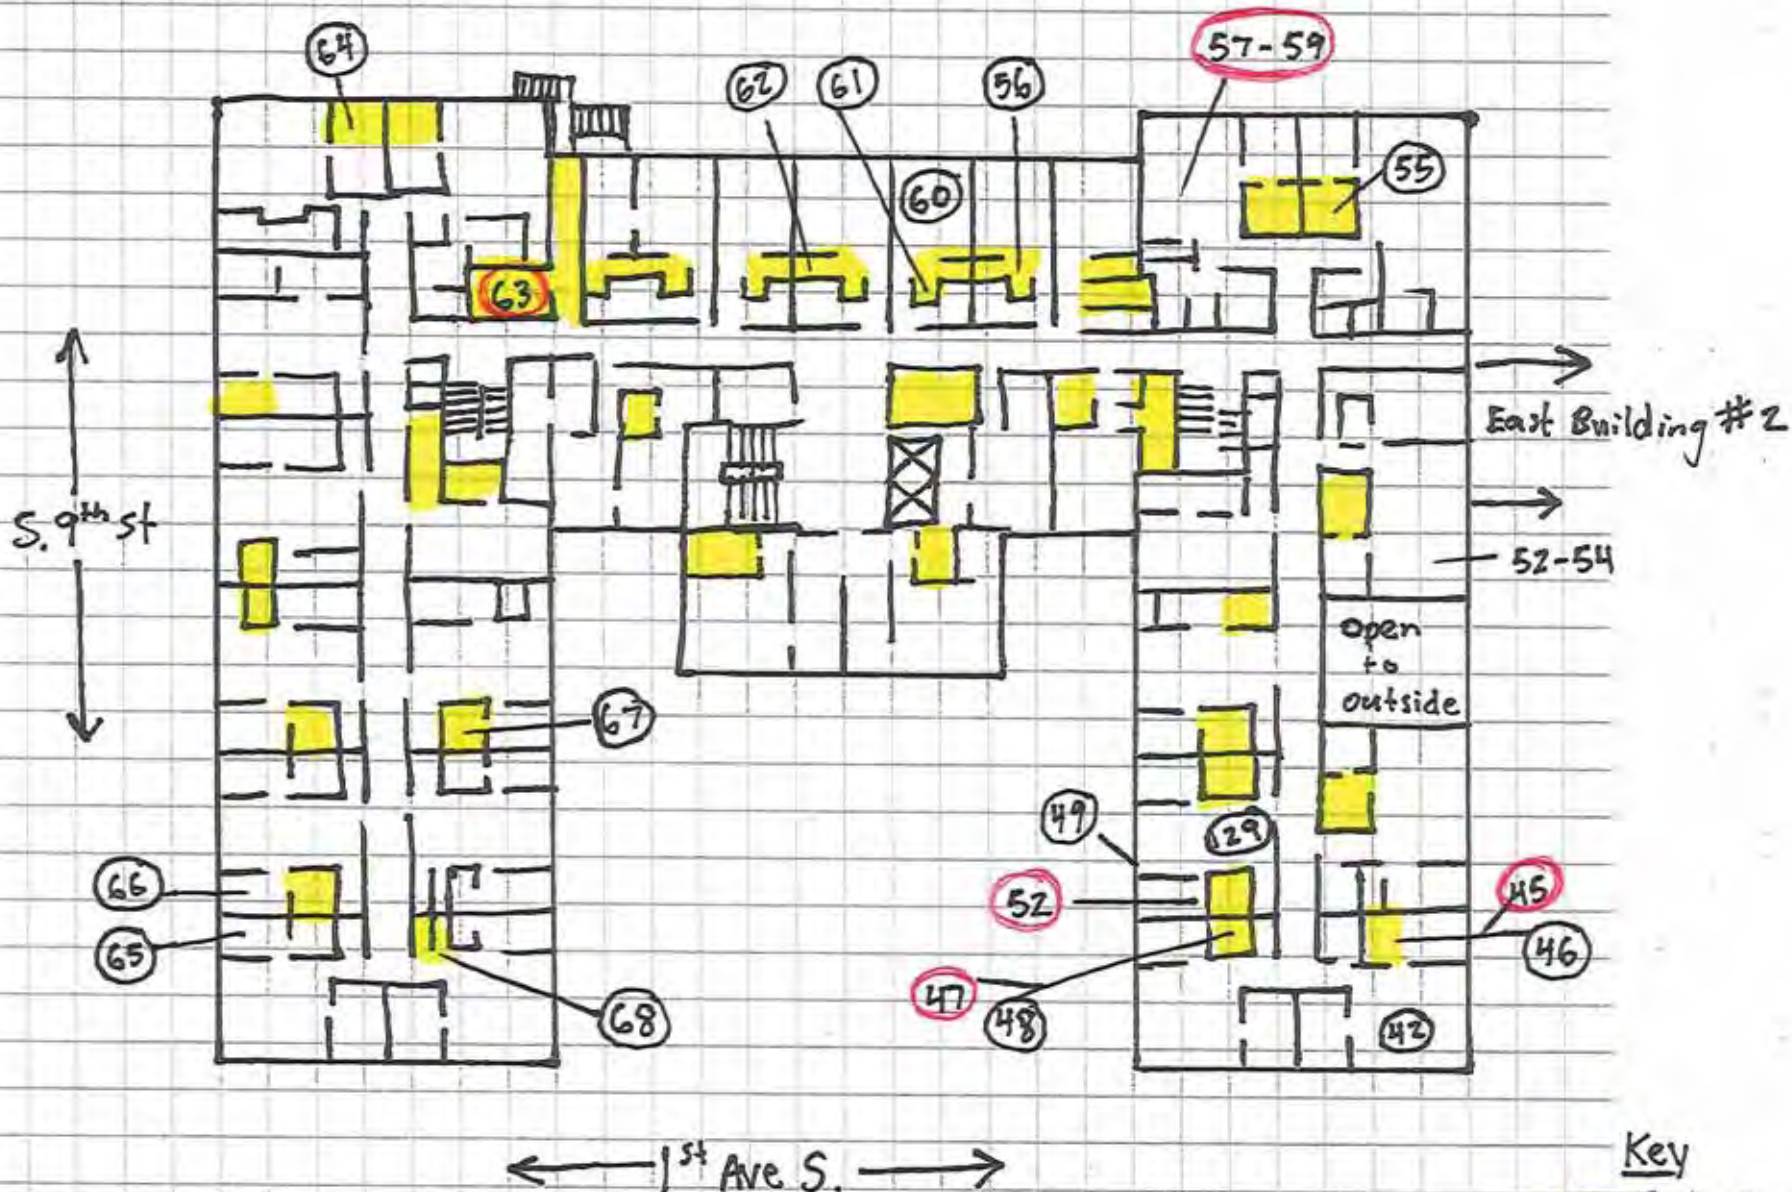
LEVEL 7

Notes for all Warden Plaza Basement to Attic
 Red circles indicate positive sample locations
 Asbestos coating on interior of exterior brick walls throughout
 Asbestos window glaze/caulk all windows
 Asbestos pipe insulation throughout

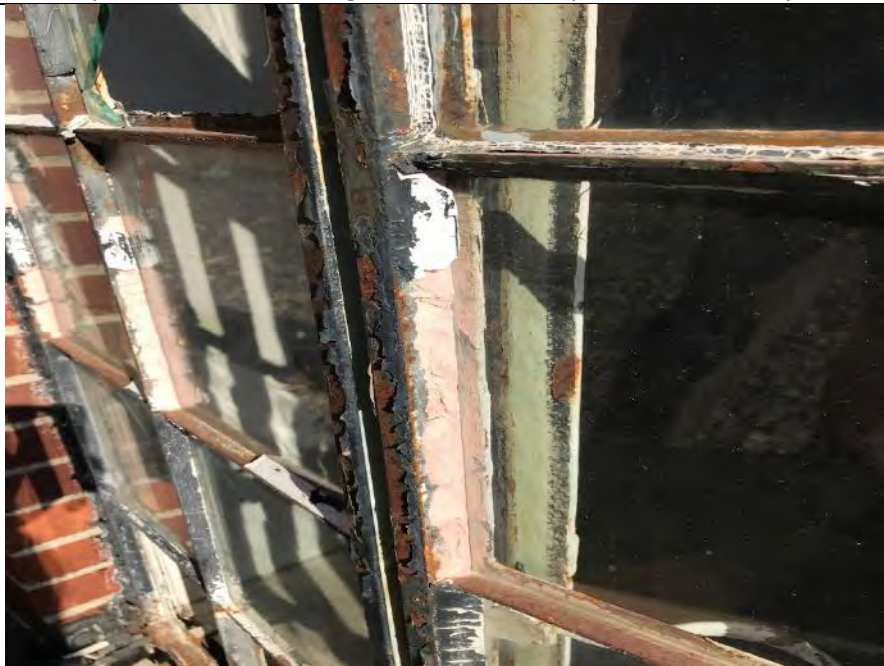
Samples 4-6 – Window Glazing – White
Sample 8 – Window Glazing – Pink

Note 1: The windows for Warden Plaza and East Building 2 contain asbestos in the glazing compounds (between the metal and glass) and the black caulk that is located around the window frame (between the brick and metal frame). Replacement window units on the first floor around the bar on the SW corner of the building have been replaced and do not contain asbestos.

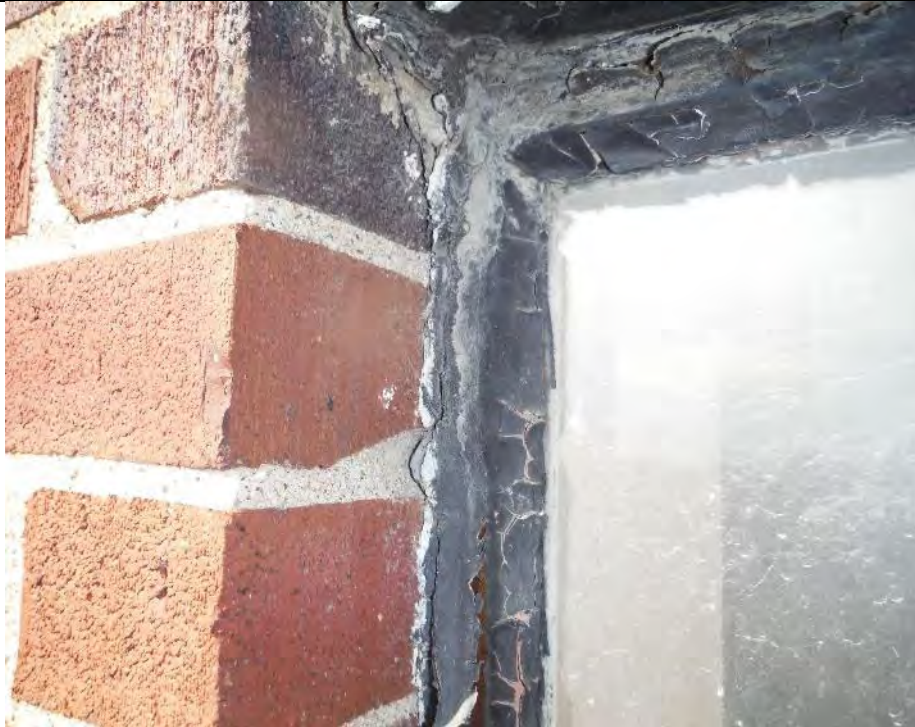
Samples 10-12 Window Frame Black Caulking between Brick and Frame

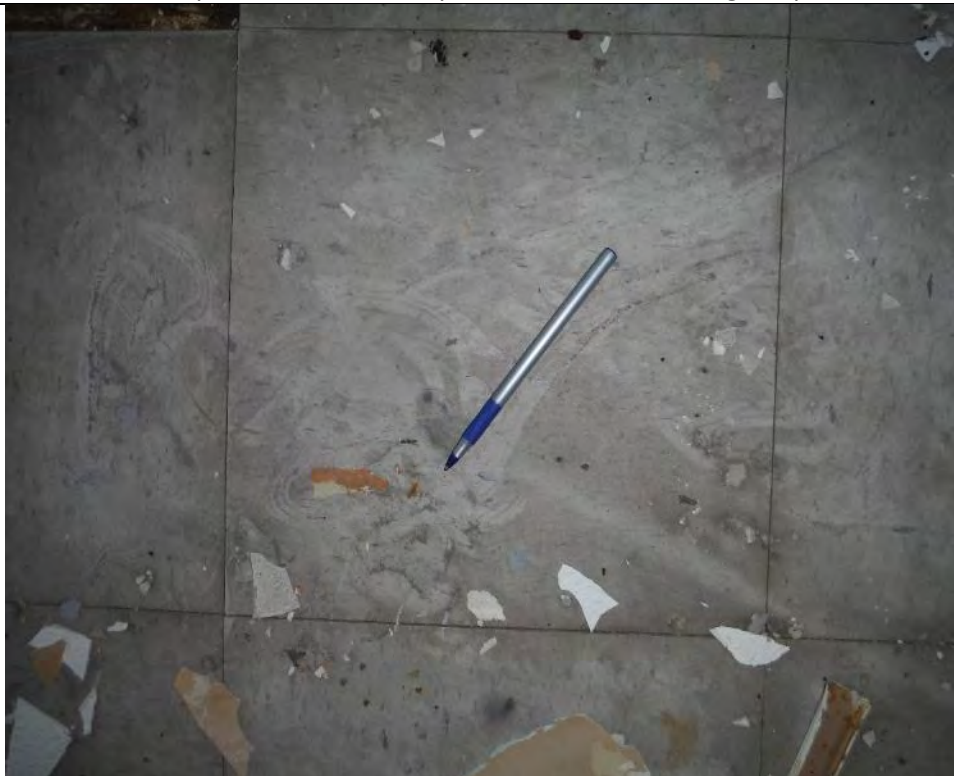
Sample 45 – 9" x 9" Floor Tile – Grey

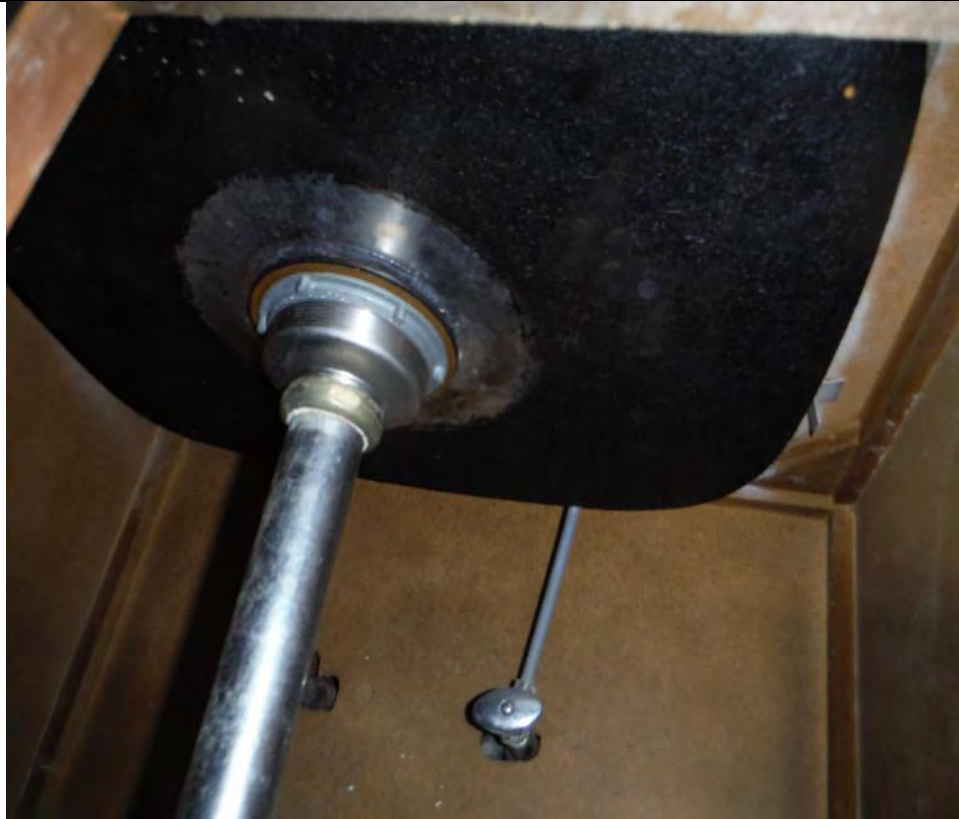
Sample 52 Sink Undercoating – Black

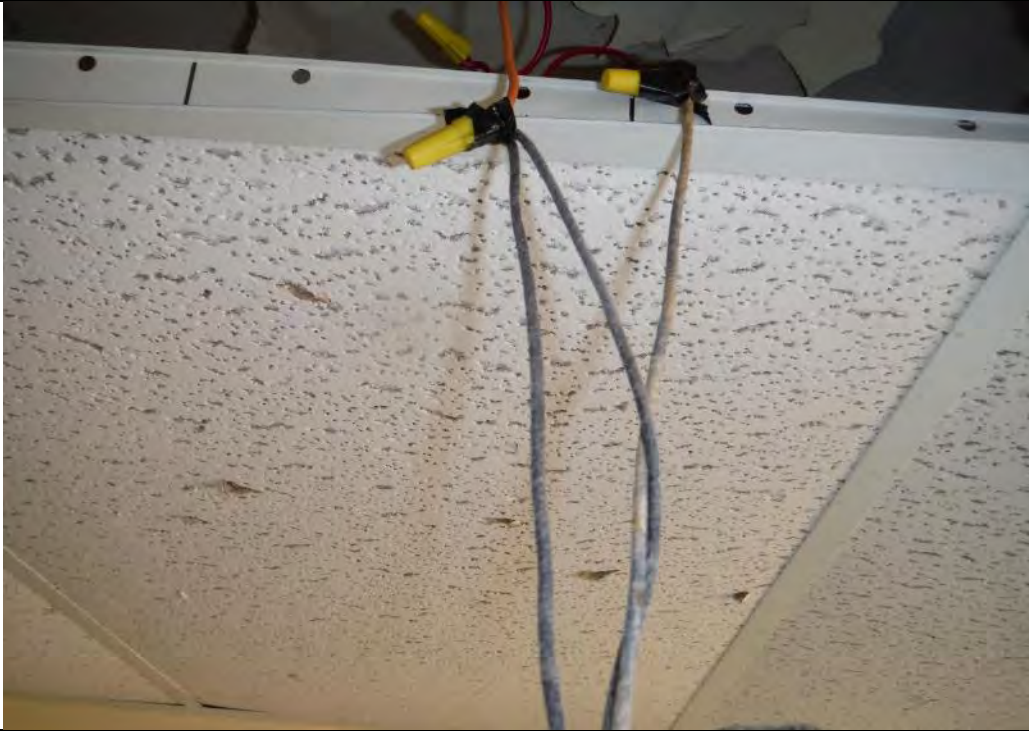
Samples 58 – 59 Electrical Wire Insulation on wires coming from Ceiling Lights

Note 5: Electrical wiring was observed to have asbestos insulation and is present throughout the wiring of both buildings. The asbestos wiring is located within wall and ceiling cavities and runs to wall switches, light fixtures, outlets and electrical equipment.

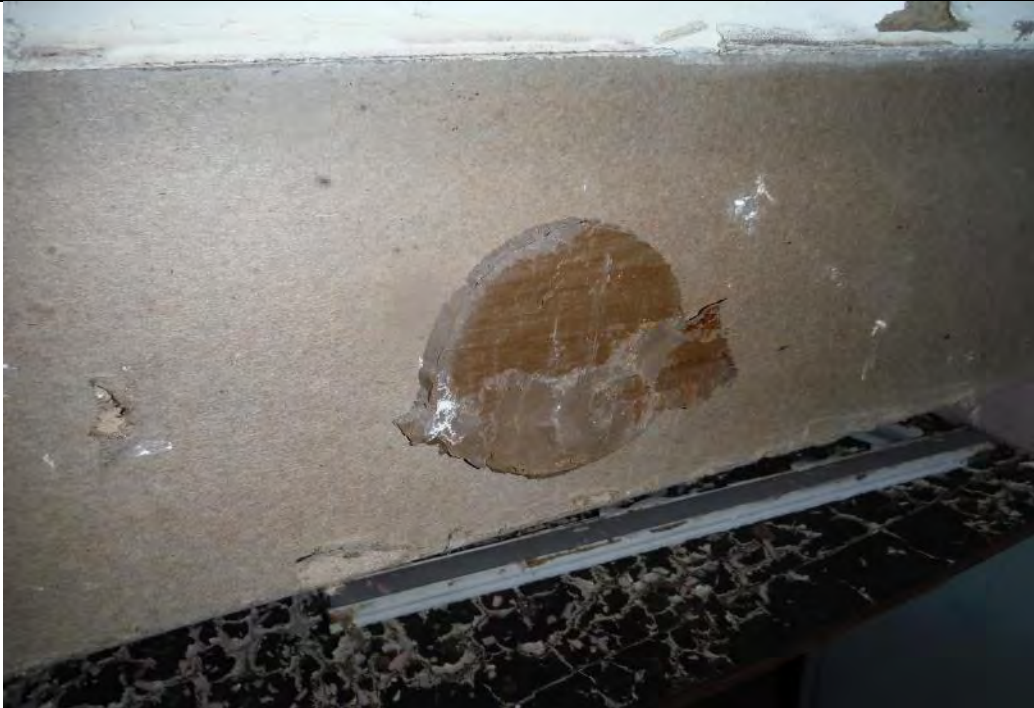
Sample 75 Brown Puck Mastic/Adhesive

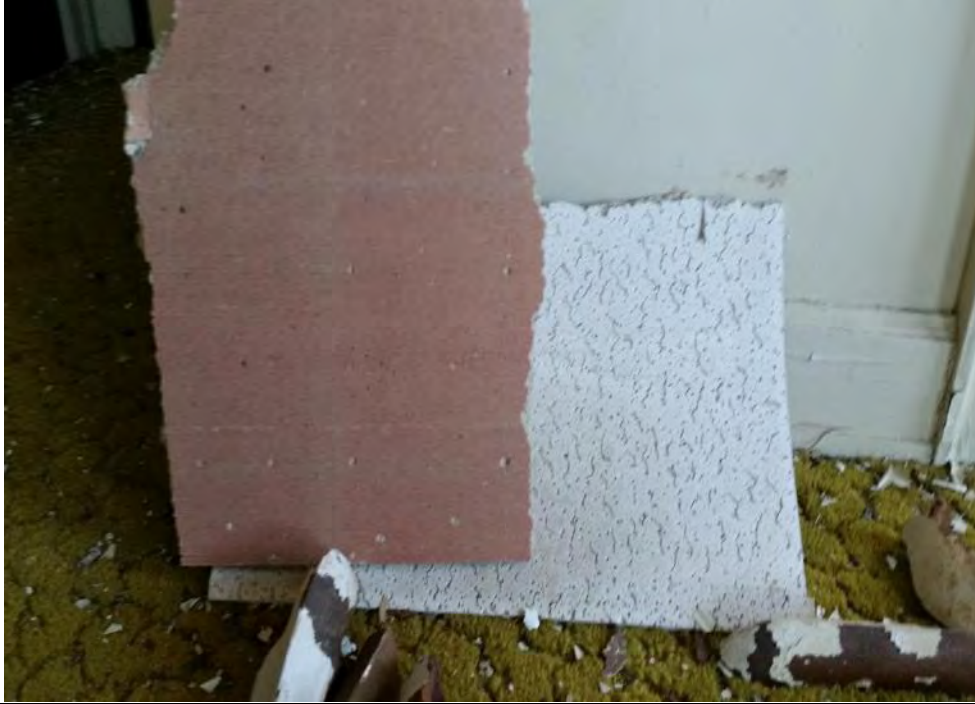
Sample 80 – Ceiling Tile 2' x 4' with Red backing

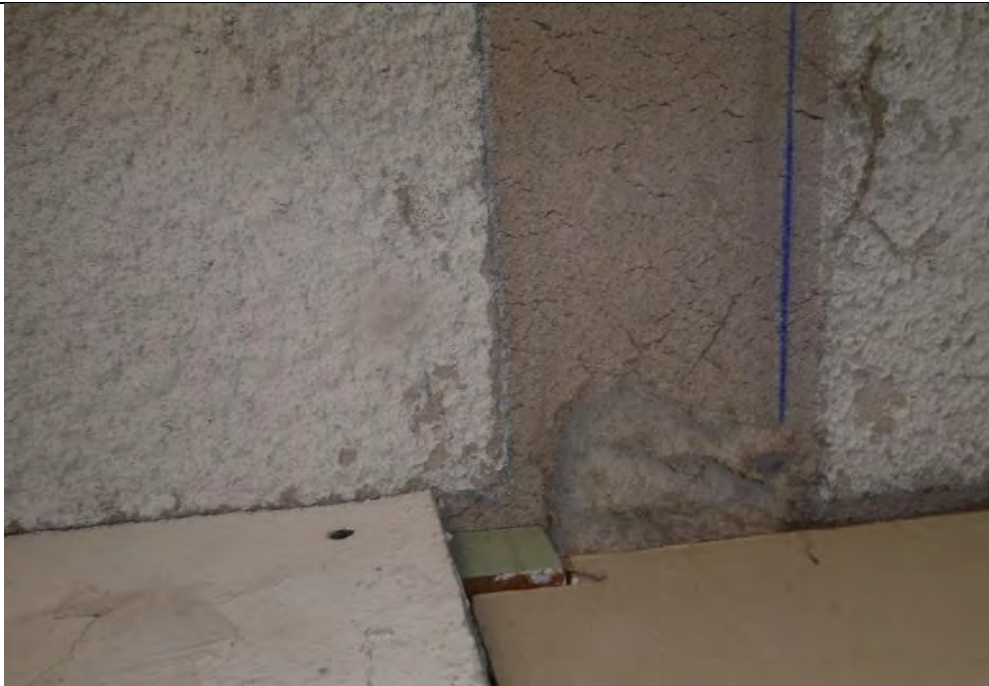
Sample 85 & 98 – 100 Ceiling Texture – White / Tan
Sample 107 – Ceiling Texture – Pink

Note 6: Friable asbestos ceiling texture is located on the 2nd, 3rd and 6th floors of Warden Plaza and is in poor condition. The ceiling texture in some locations has fallen to the floor and has contaminated the ground with asbestos in the immediate area.

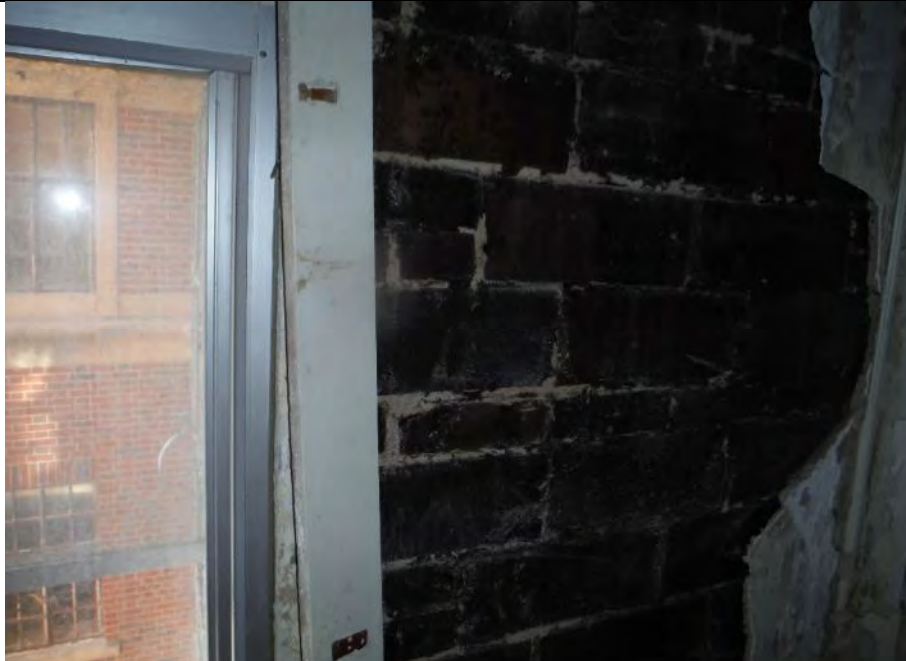
Sample 105 – Black Waterproofing on the inside of the exterior walls

Note 7: An asbestos-containing black vapor barrier or waterproofing coating is on the interior of the exterior brick walls of Warden Plaza. This coating was not observed in East Building 2 and additional destructive inspection for East Building 2 is recommended to verify it was not hidden by wall systems.

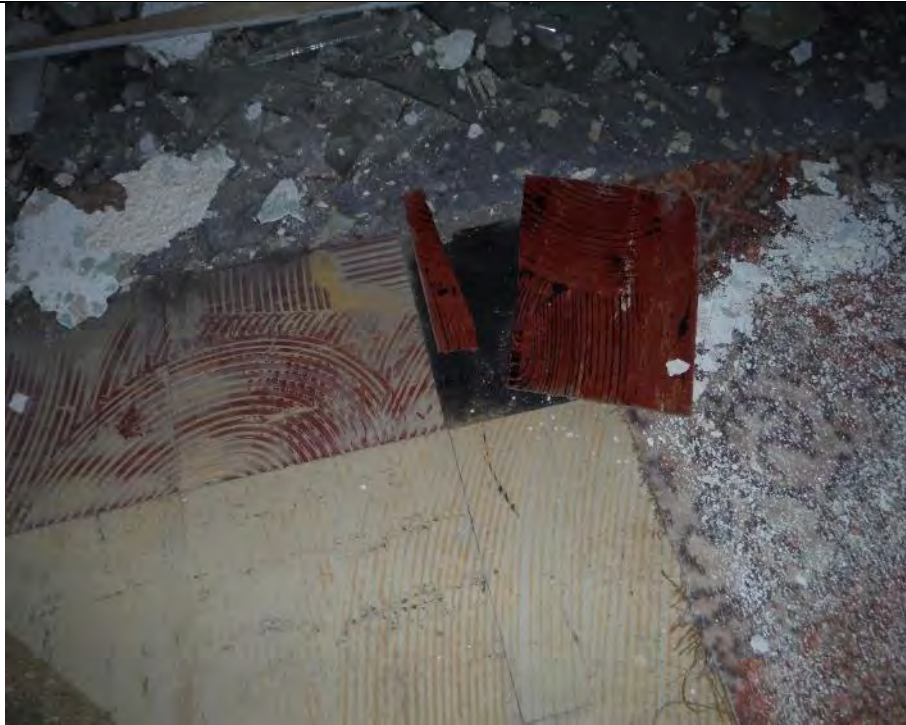
Sample 109 – 9" x 9" Floor Tile – Red

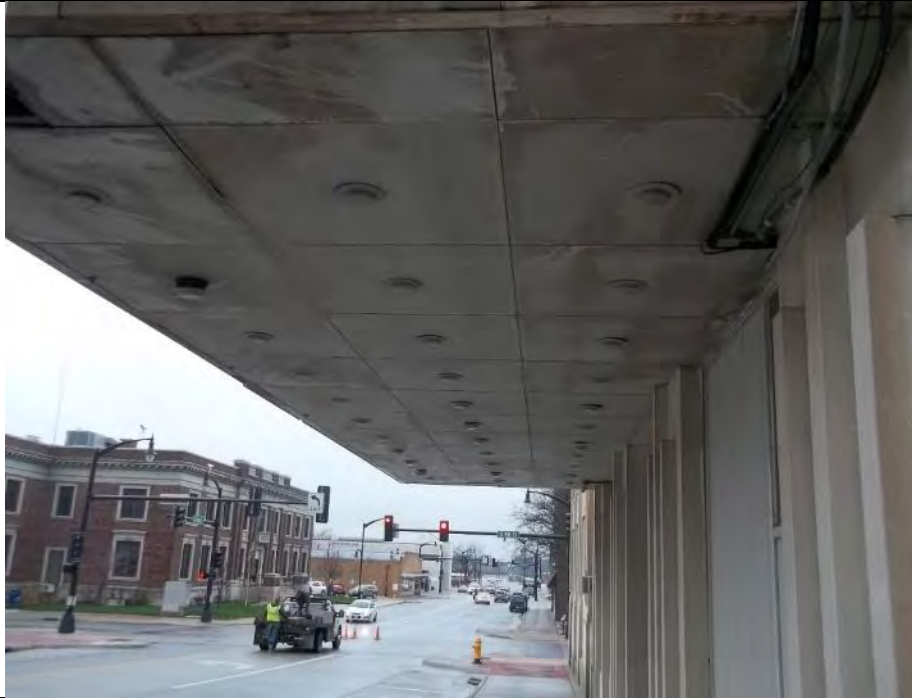
Sample 90 - Transite Soffit over entrance on 1st Ave S.

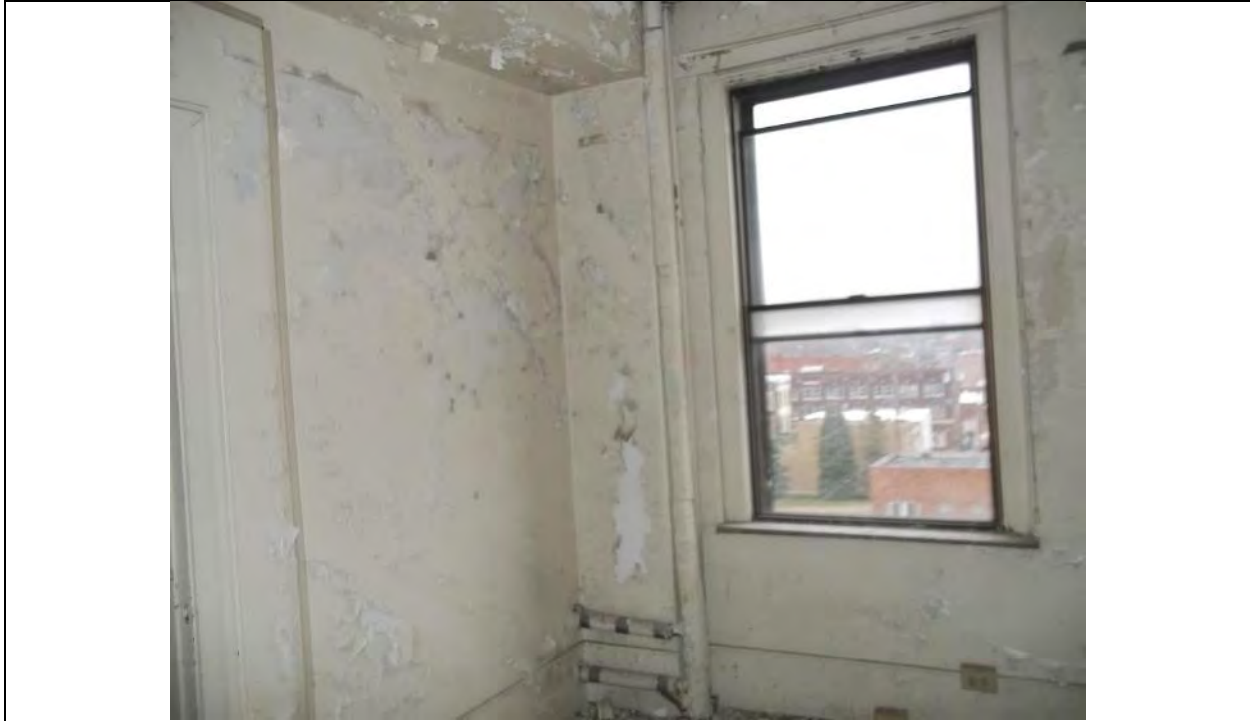
Samples 163- 165 Window Glazing - Grey

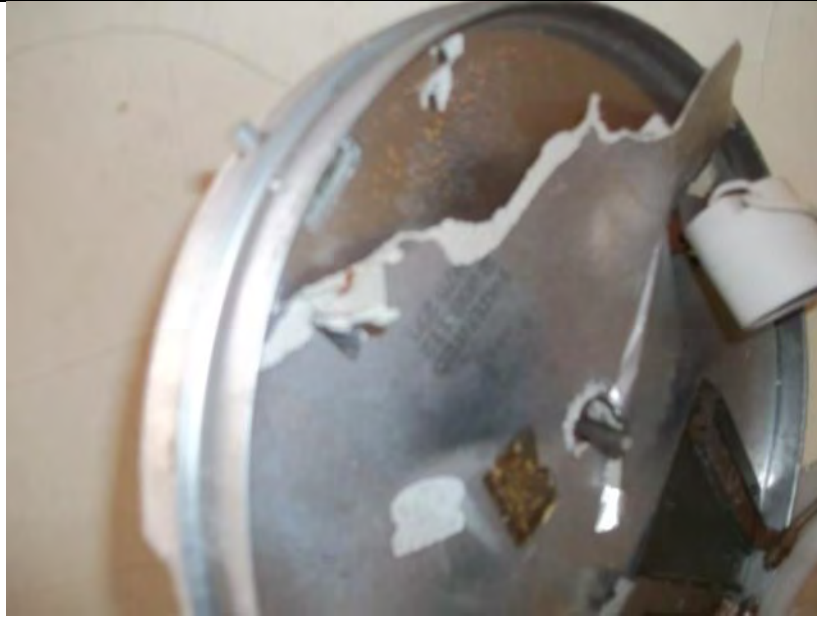
Samples 169 – 171 Heat Shields in circular ceiling lights

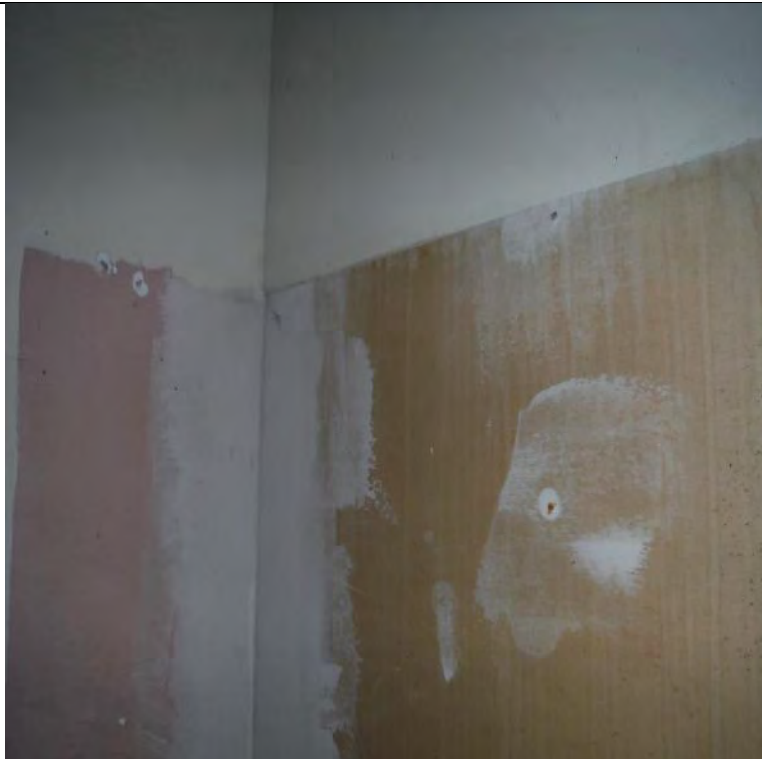
Sample 172 – 174 Drywall and Joint Compound

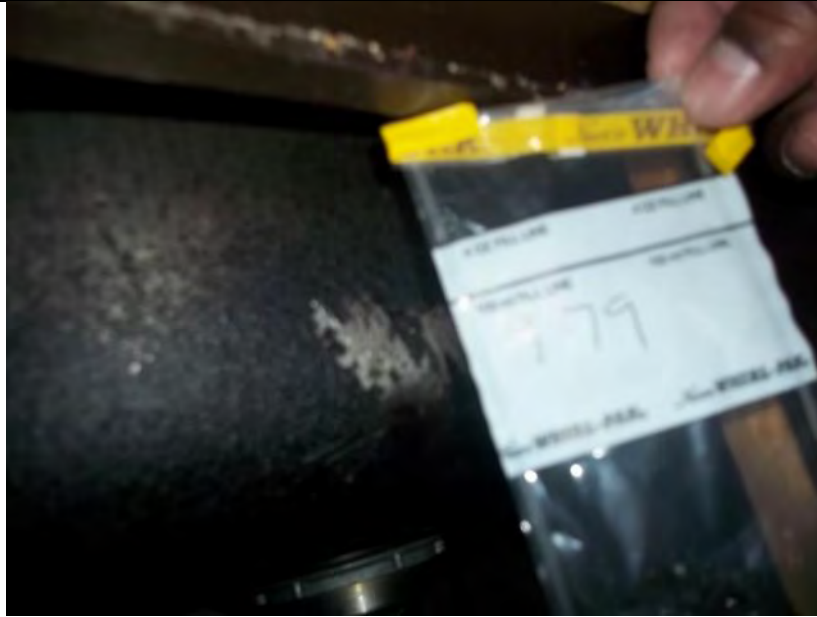
Sample 179 Sink Undercoating – Black

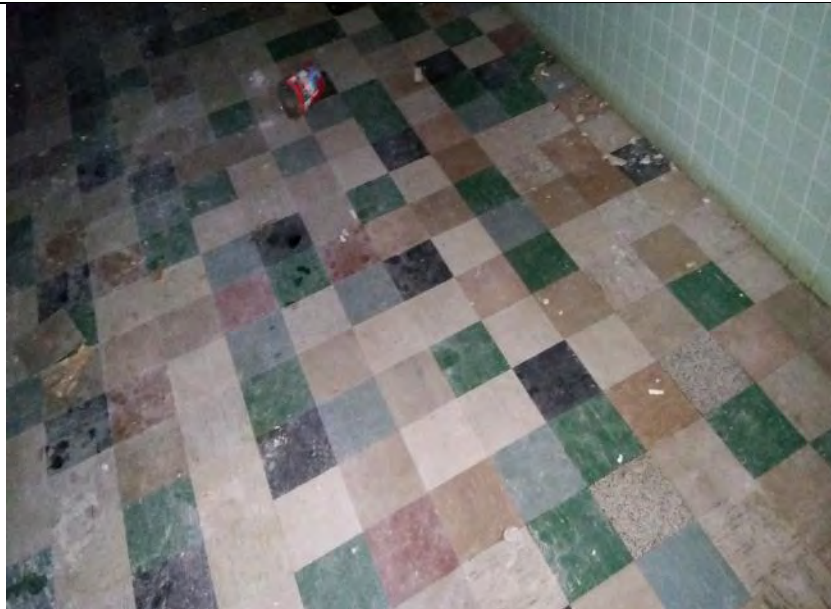
Sample 185 - 188 9" Floor Tile Multiple colors

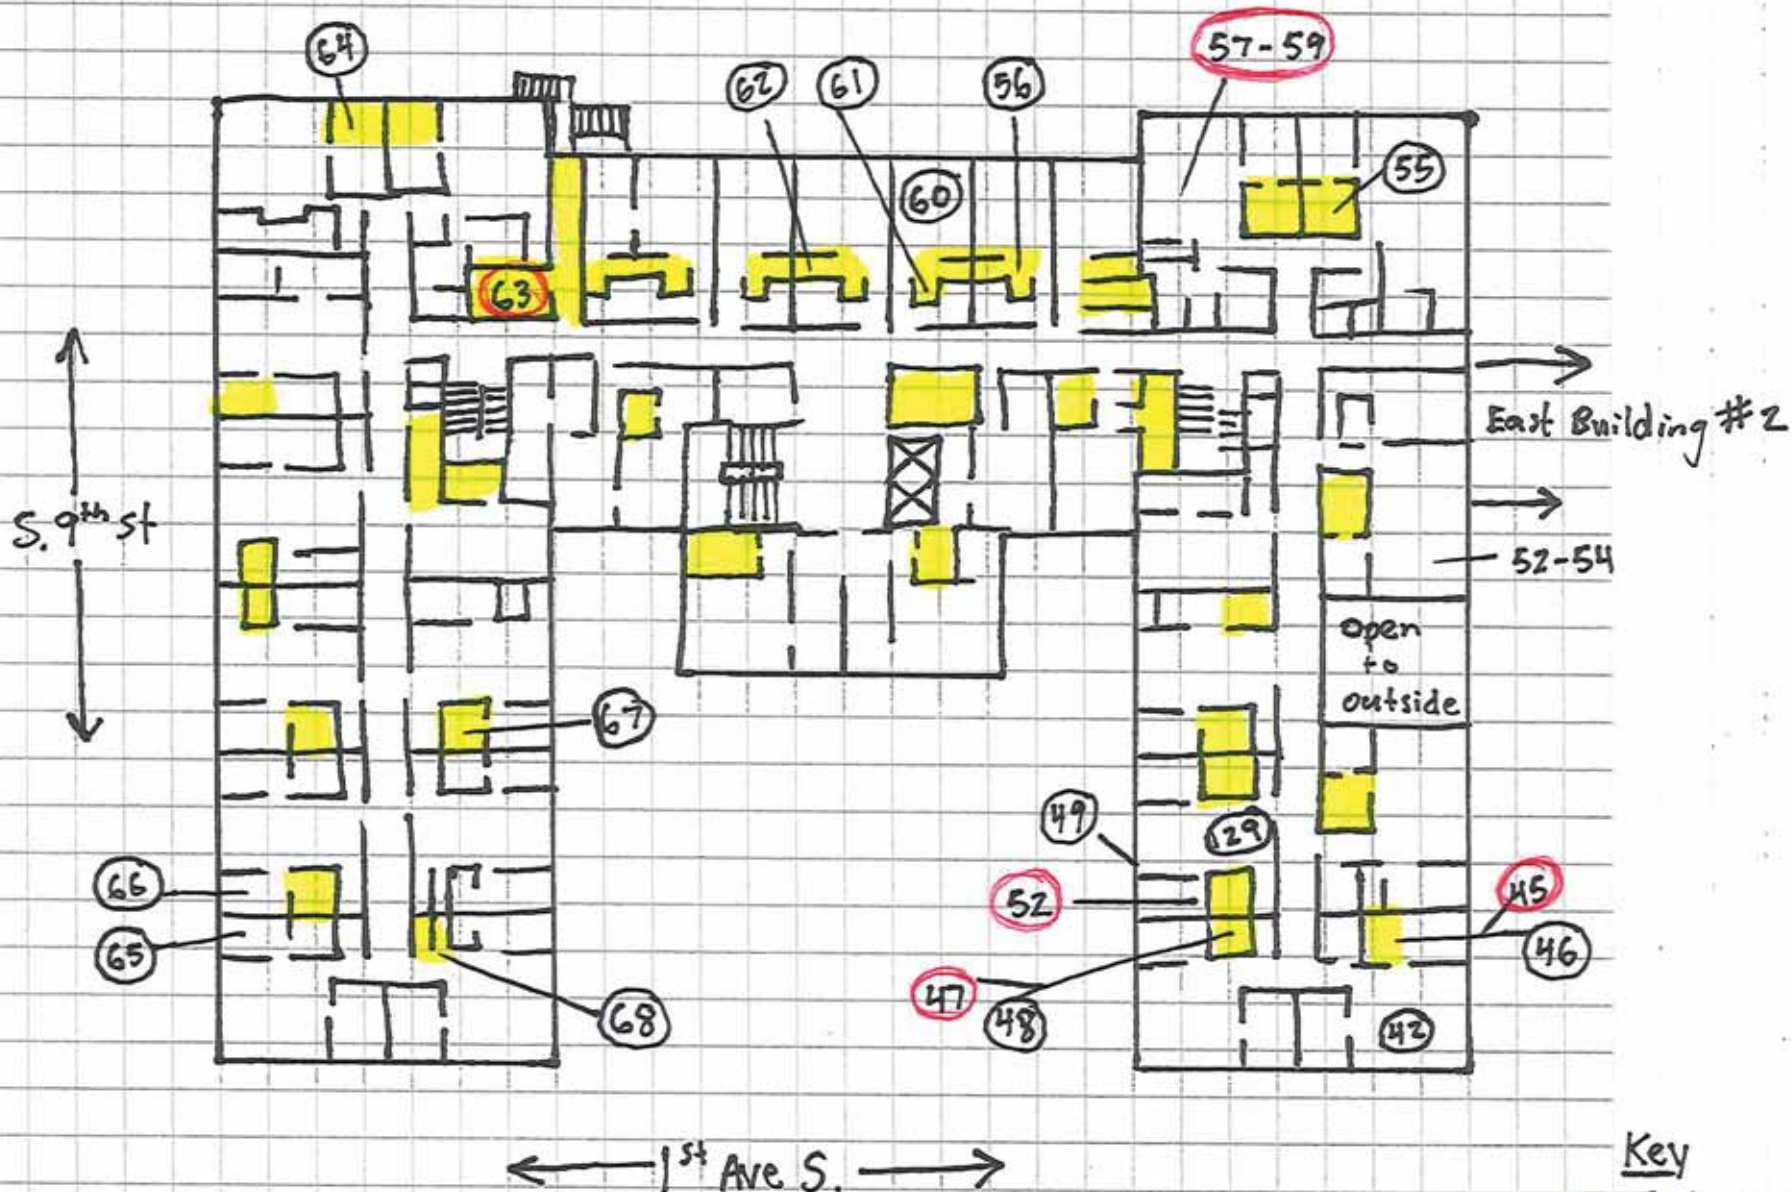
LEVEL 7

Notes for all Warden Plaza Basement to Attic
 Red circles indicate positive sample locations
 Asbestos coating on interior of exterior brick walls throughout
 Asbestos window glaze/caulk all windows
 Asbestos pipe insulation throughout

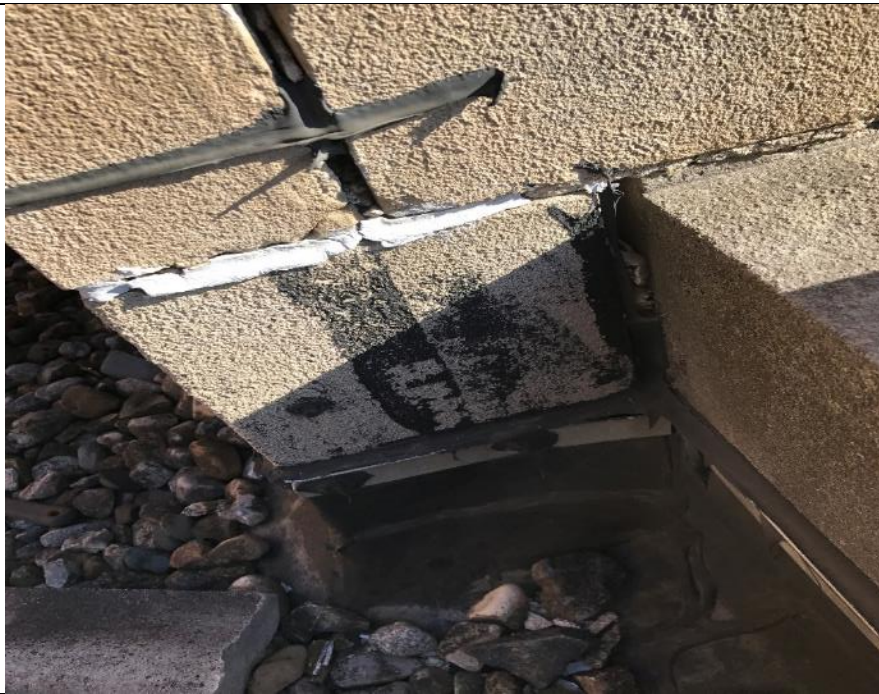
Sample 2 – White Caulking on Concrete Parapet wall – 2nd Story Roof

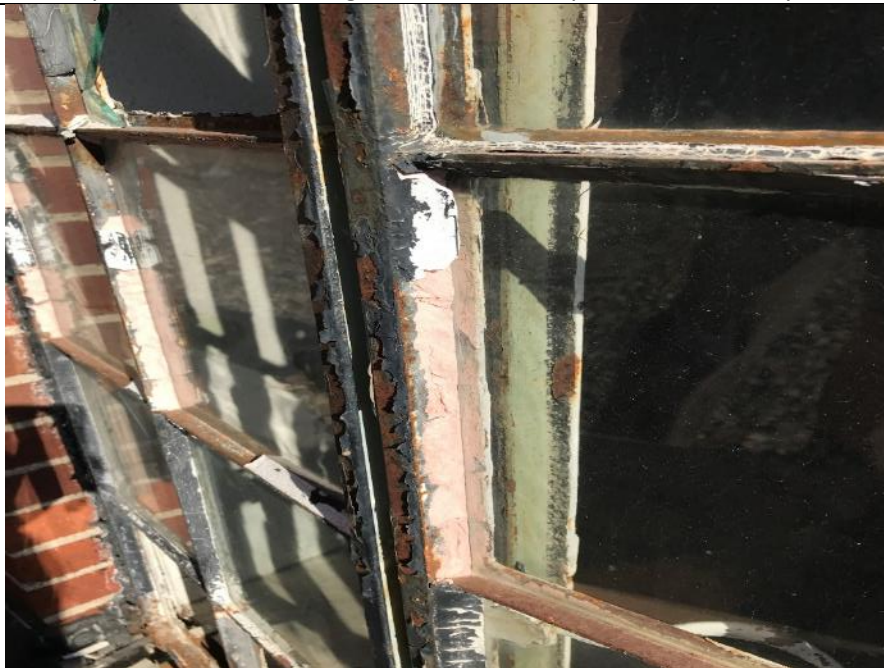
Samples 4-6 – Window Glazing – White
Sample 8 – Window Glazing – Pink

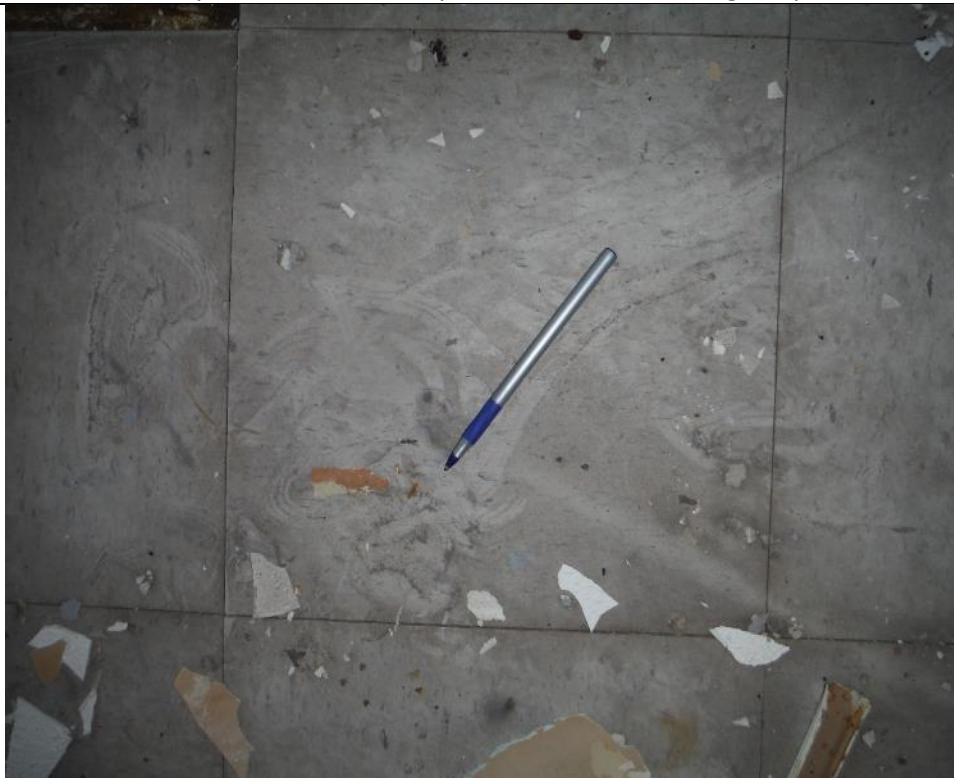
Sample 45 – 9" x 9" Floor Tile – Grey

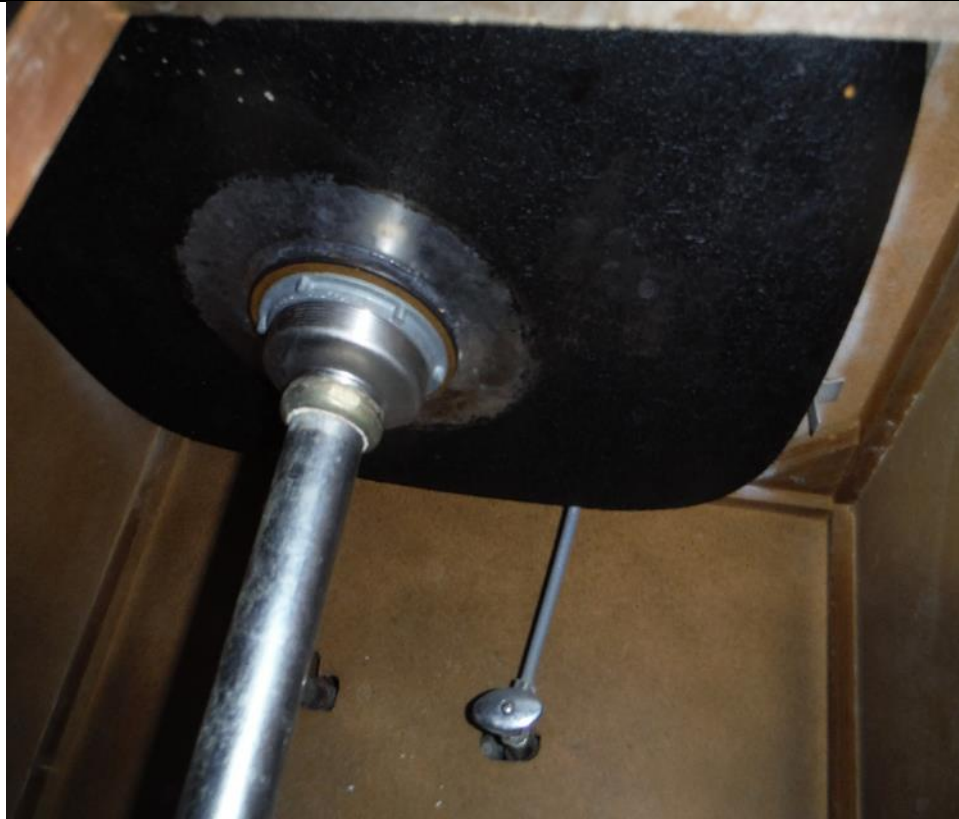
Sample 52 Sink Undercoating – Black

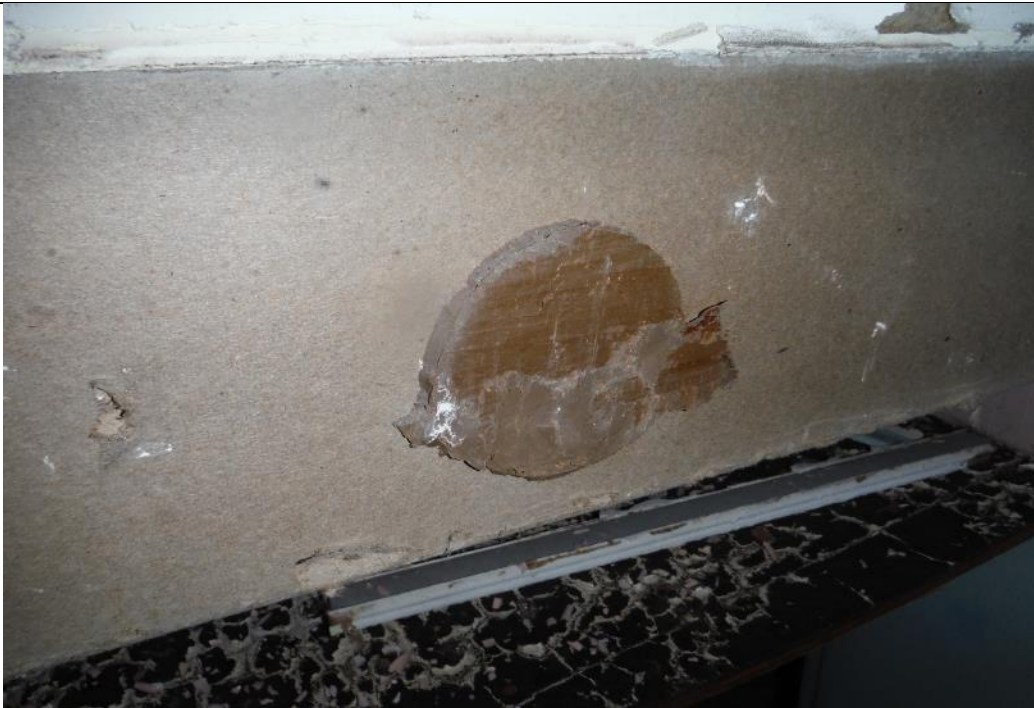
Sample 75 Brown Puck Mastic/Adhesive

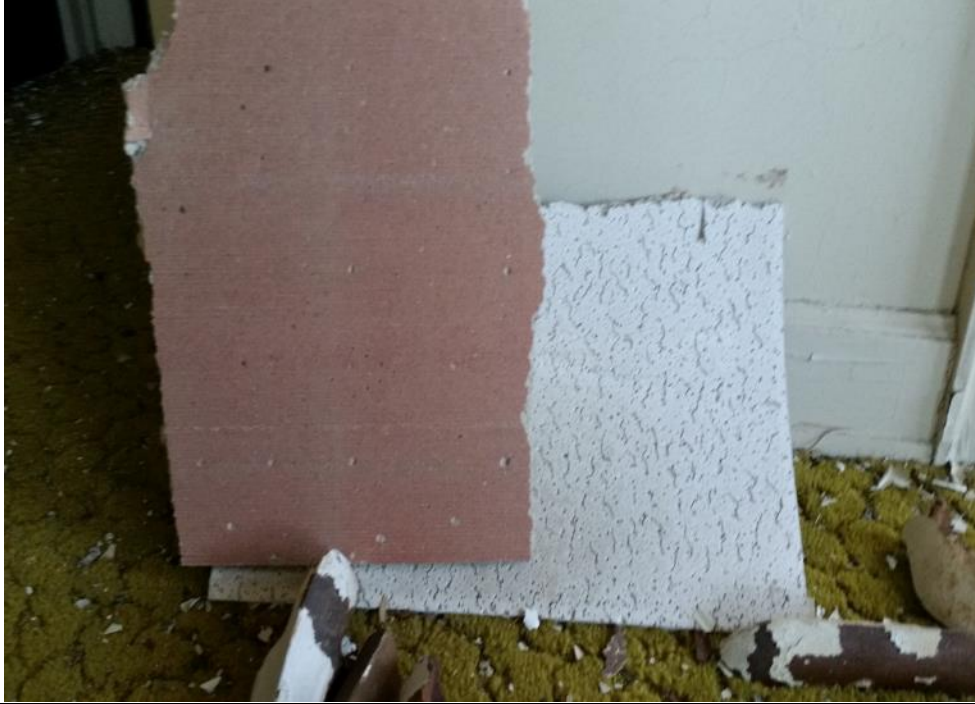
Sample 80 – Ceiling Tile 2' x 4' with Red backing

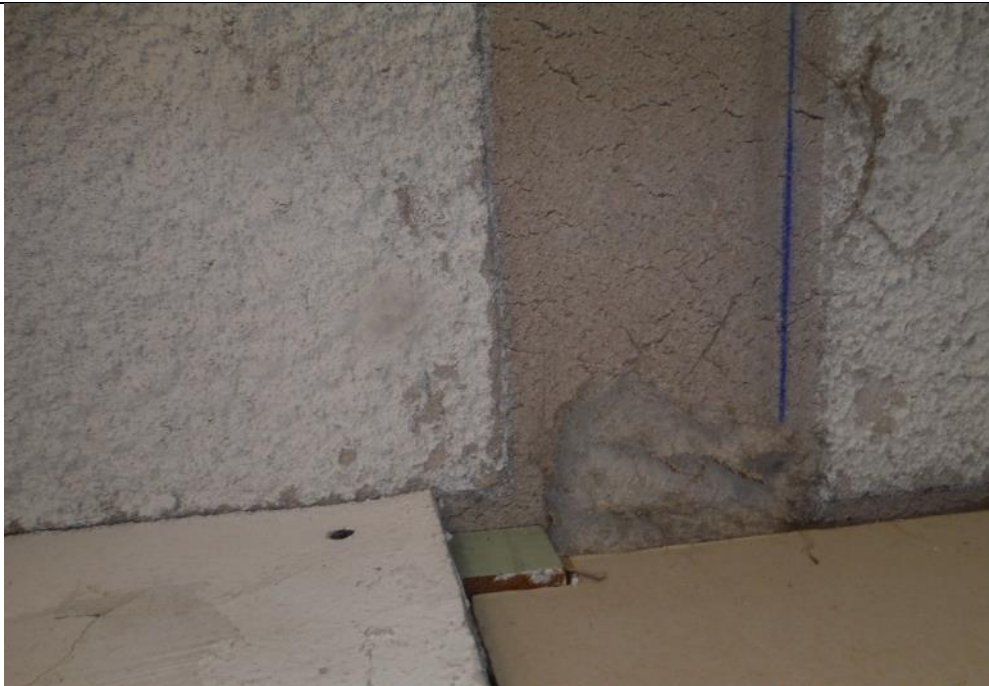
Sample 85 & 98 – 100 Ceiling Texture – White / Tan
Sample 107 – Ceiling Texture – Pink

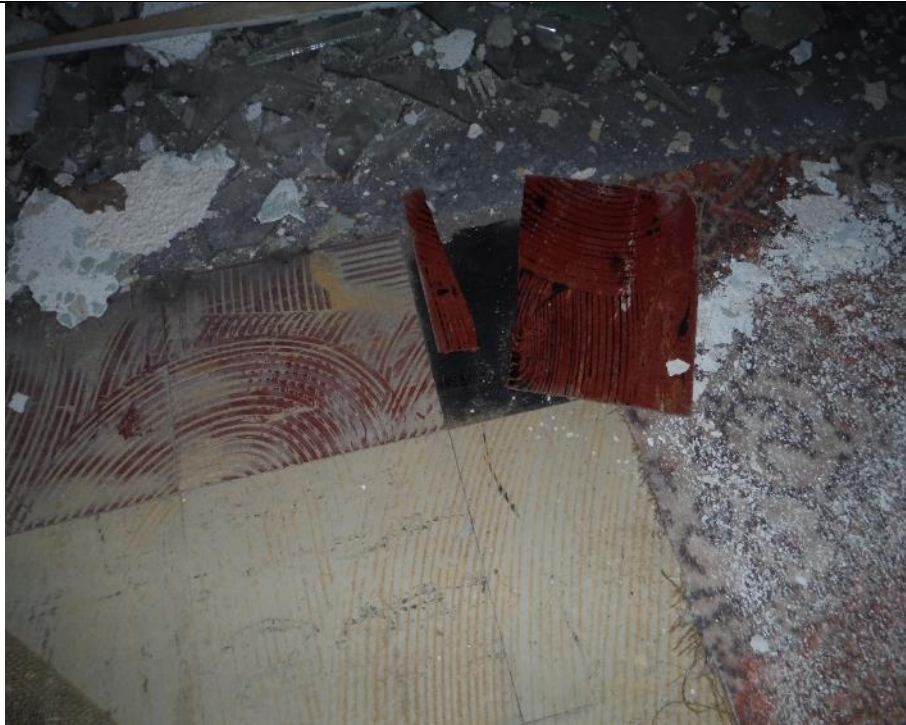
Sample 109 – 9" x 9" Floor Tile – Red

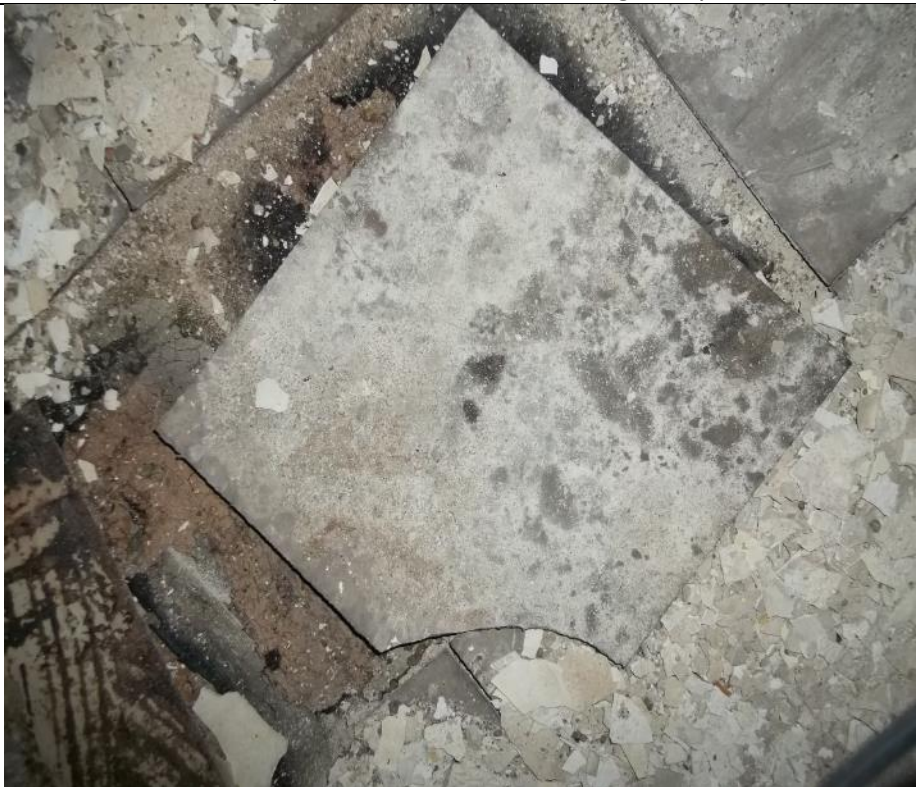
Samples 166 – 168 9” Floor Tile – Grey

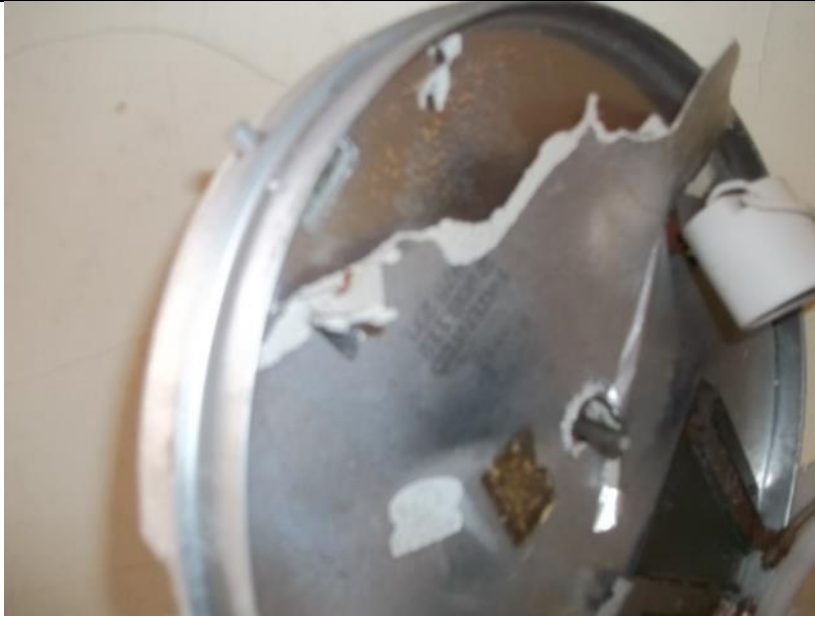
Samples 169 – 171 Heat Shields in circular ceiling lights
