ANALYSIS OF BROWNFIELDS CLEANUP ALTERNATIVES

**Warden Plaza
908 1st Avenue South
Fort Dodge, Iowa 50501**

**City of Fort Dodge
819 1st Avenue S.
Fort Dodge, Iowa 50501**

October 18, 2023

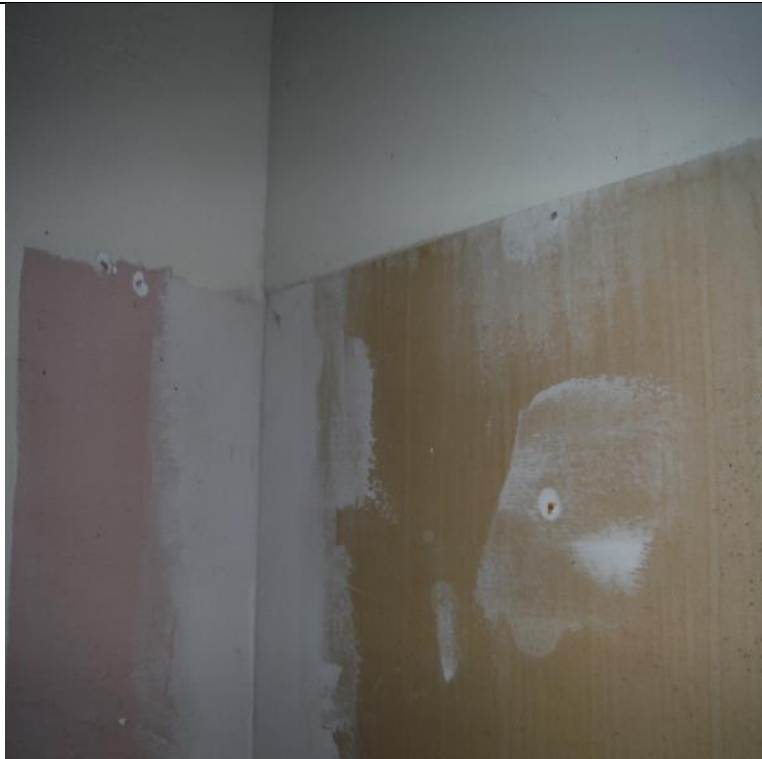
Sample 172 – 174 Drywall and Joint Compound

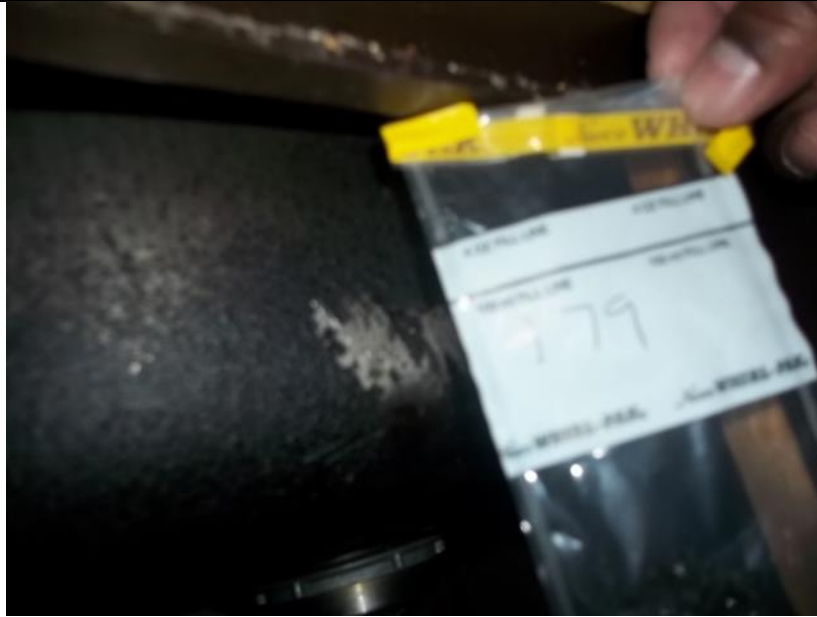
Sample 179 Sink Undercoating – Black

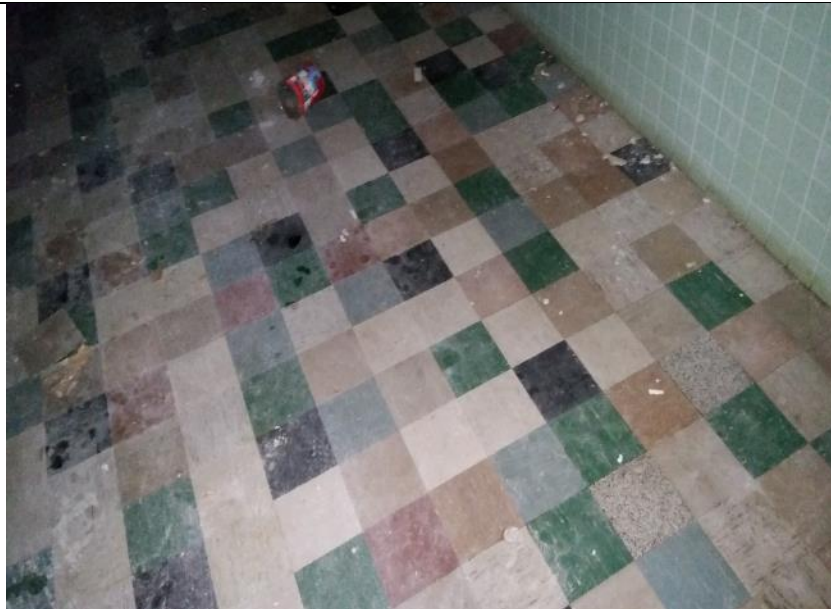
Sample 185 - 188 9" Floor Tile Multiple colors

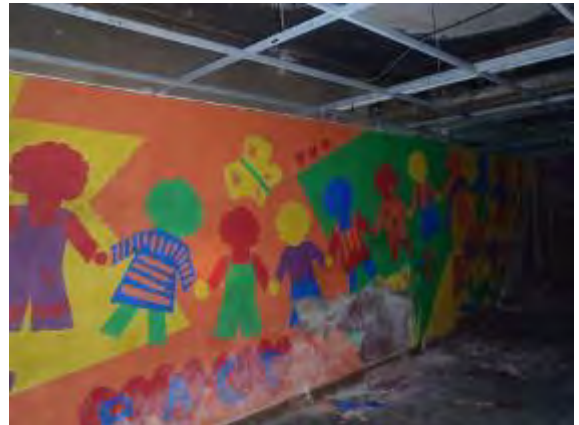
Basement-Nursery Wall

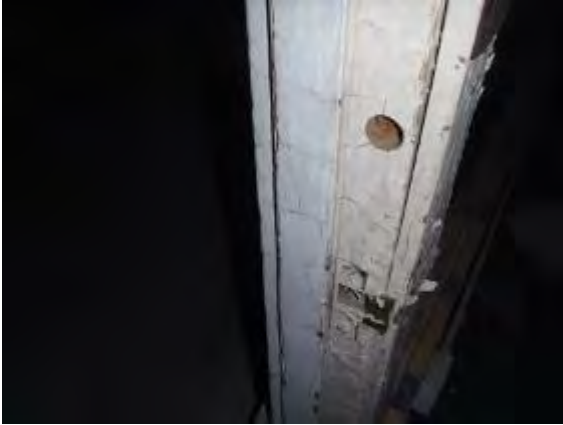
Door Components Throughout

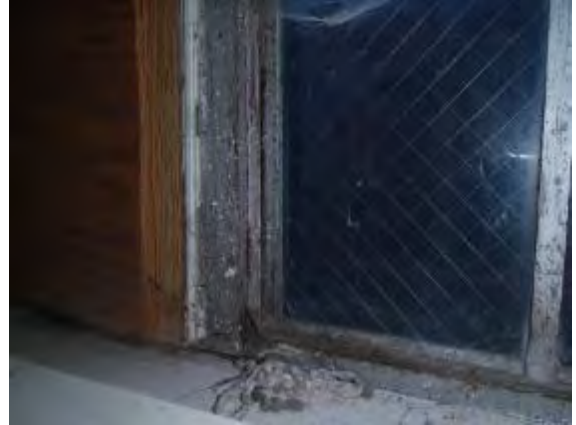
Window Components Throughout

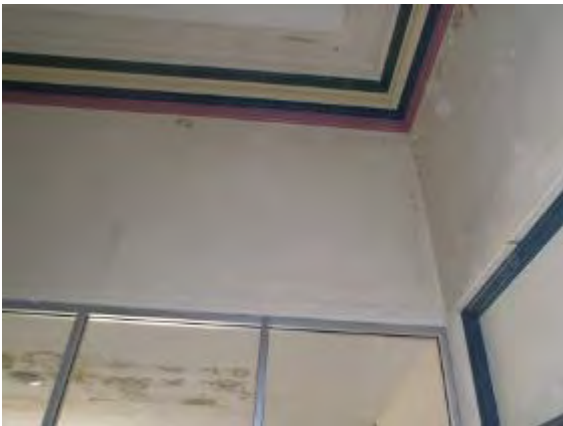
Style of Crown Molding Throughout

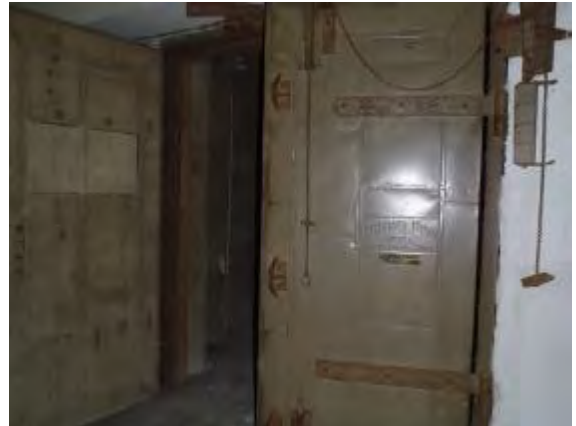
Doors

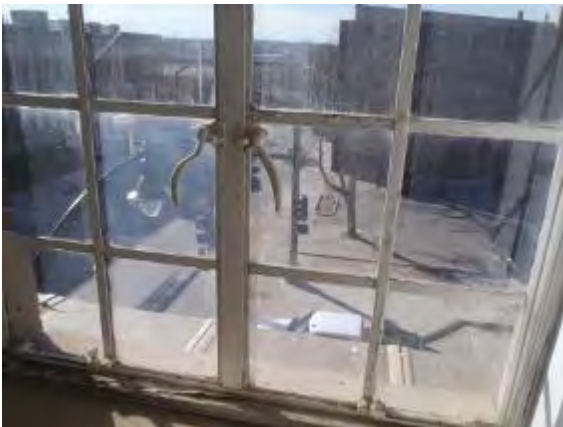
Windows Throughout

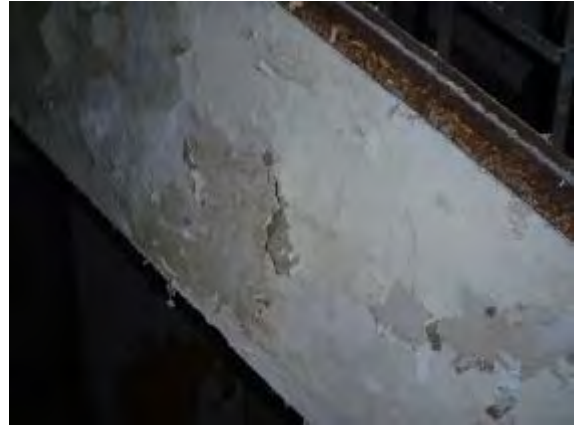
Stair Stringer

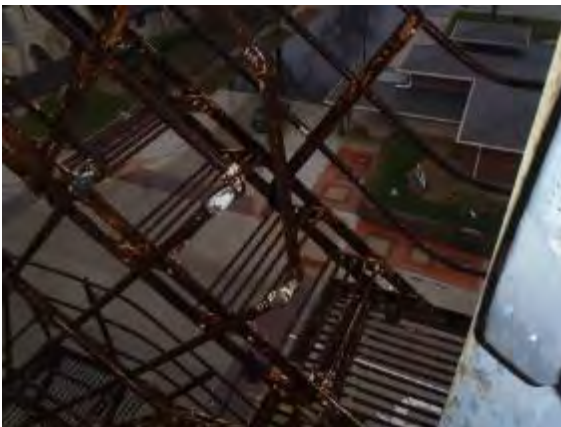
Fire Escape

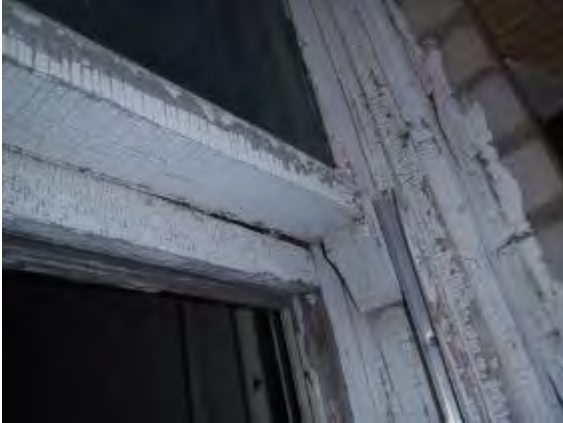
Exterior Window Components

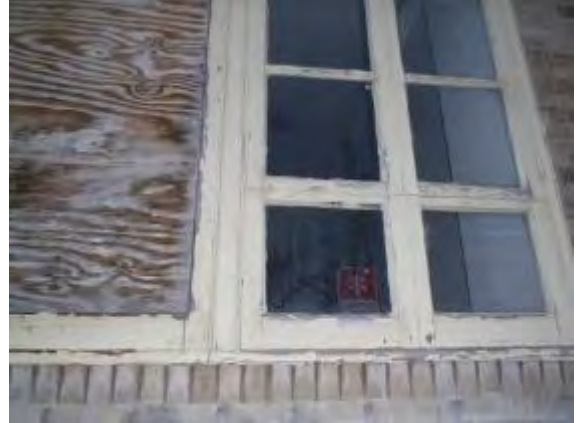
Exterior Window Components

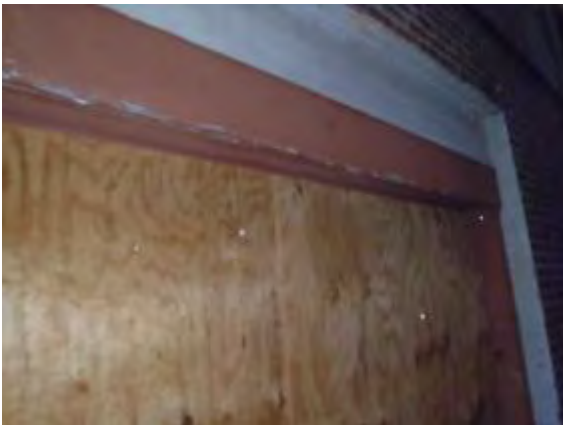
Exterior Window Components
